# Multi-State Vegetative Treatment System Technology: Implementation and Performance - Final Report

**Dr. Matt Helmers, Associate Professor, Iowa State University**  
**Daniel Andersen, Graduate Research Assistant, Iowa State University**  
**Brad Bond, Project Engineer, Curry-Willie & Associates**  
**Dr. Robert Burns, Associate Dean of Extension, University of Tennessee**  
**Dr. Chris Henry, Extension Engineer, University of Nebraska-Lincoln**  
**Dr. Todd Trooien, Professor, University of South Dakota**  
**Stephen Pohl, Professor, University of South Dakota**  
**Crystal Powers, Extension Engineer, University of Nebraska-Lincoln**  
**Duane Gangwish, Chief Executive Officer, Iowa Cattlemen's Association**

**Duration of Project:** 11/30/07 to 10/21/10

This is the final report for the Multi-state vegetative treatment systems: implementation and performance project. The report provides a concise description of the project, monitoring results, and conclusions obtained. The first section contains a summary of the data collected and our recommendations, based on the monitoring results and experiences with these systems, on how to site, design, and manage successful vegetative tre

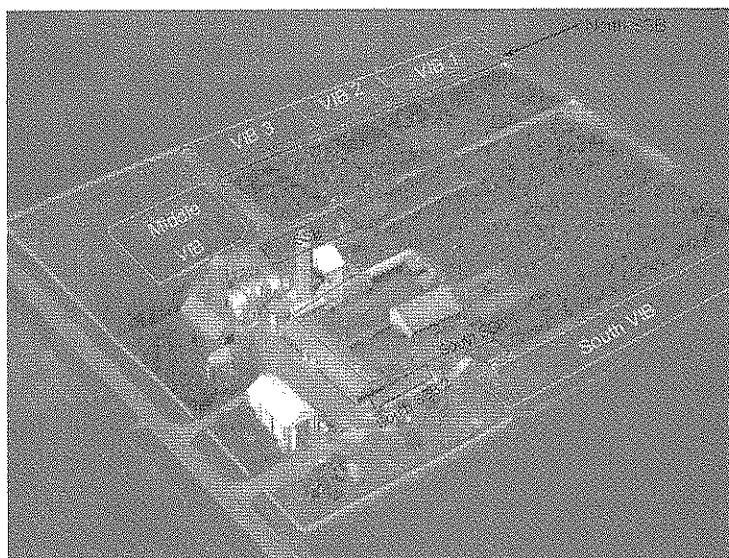
vertical plastic strips spaced 2 cm apart. During 2006 the producer placed a “fence” of soybean stubble/straw round bales in the settling basin to further slow and to filter the flow. In 2007 the porous dam and round bale filter were removed from the settling basin and not used. A gate valve was installed during the summer of 2007 at the settling basin outlet to provide the operator with more control over when, how much, and at what rate effluent was released to the VIB. Due to poorer solid-liquid separation during 2007, the producer decided to use the round bale filter along with the gate valve in 2008 and 2009. Effluent from the SSB was released via a 30.5-cm diameter PVC pipe to the vegetative infiltration basin (VIB).

Wet conditions in the VIB made it difficult to establish and maintain vegetation in this treatment component. Reed canary grass was reseeded in 2007 and 2008 to improve stand quality. The 0.32-ha VIB was surrounded by 1.2 m high berms and provided storage for the 25-year, 24-hour storm within the vegetative treatment system. The VIB had 10 cm (4 inch) diameter perforated tiles, spaced 6 m apart, installed approximately 1.2 m below the soil surface. A perimeter tile was installed around the VIB to intercept outside groundwater flow and prevent it from entering the VIB. Flow from the VIB tile lines was collected in a concrete sump and pumped onto a 0.2 ha VTA (Middle VTA). Gated pipe was used to spread VIB effluent evenly across the top width of the VTA. Flow then proceeded down the length of the VTA via gravity drainage. Both the VIB and VTA were planted with a mixture of reed canary and brome grass initially, with canary grass becoming the predominant species during the first two years of system operations.

Figure 3. Feedlot and installed runoff control system.

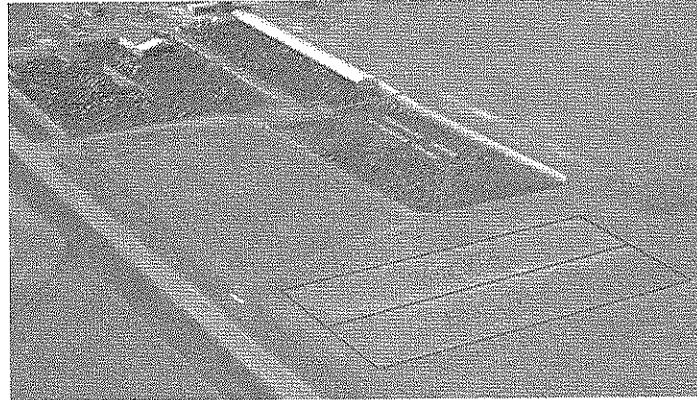
This site utilized a vegetative infiltration basin (VIB) and a vegetative treatment area (VTA) system to control runoff from a 2.96-ha concrete feedlot (Figure 7). A concrete settling basin of 1,120 m<sup>3</sup> capacity collected runoff from the feedlot. The SSB was 1.2 m deep and had a V-notch weir at the outlet. Effluent flowing through the V-notch weir entered a concrete channel and went through an H-flume for measurement. In 2008, a series of stop-blocks were added to the SSB outlet to control effluent release into the VIB. The stop-blocks were constructed from five cm diameter PVC pipe and stacked at the SSB outlet. The stop-blocks were then removed, from the top down, to dewater the SSB. Solids at this site proved difficult to settle, even after the addition of the stop block control. To improve solids removal from the SSB effluent, a biomass filter was constructed in the summer of 2009. The biomass filter was approximately 5 m wide and 3 m long. Corn stover and/or corn cobs were used as biomass material in the filter. The biomass was added to the filter as a loose material, and then compressed to a depth of 0.5 m by adding weight to the top of the material. SSB effluent flowed through this filter prior to release into the VIB. The PVC stop-block control system was used to meter the rate at which effluent was allowed to enter the filter.

Figure 7. Feedlot and installed runoff control system.

Effluent from the settling basin was released into a 1.01-ha VIB. The VIB had 15 cm diameter perforated tiles installed 1.2 m deep and spaced 4.6 m apart. The VIB was built 0.9 m deep in the ground, and provided storage for a 25-year, 24-hour storm runoff with an additional 0.3 m of freeboard before a VIB overflow would occur. Wet conditions in the VIB made it difficult to maintain vegetation. In 2008, a surface inlet with a control valve was added to drain effluent from the VIB during periods of prolonged ponding. Flow from the tile lines and surface drain was collected in a sump and pumped onto the VTA. The 0.60-ha VTA was divided into two, 27 m wide channels. At a given time, effluent was pumped onto only one of the channels. The channel receiving effluent was controlled by valves that were manually switched by the producer. A gated pipe was used to spread flow evenly across the top width of the VTA channel. Effluent reaching the bottom of the VTA channels was captured by a surface inlet and routed back to the VIB through a 15 cm PVC pipe. In 2009 a third 0.30-ha VTA was constructed. Use of the VTA began in the fall of 2009 after vegetation was established.

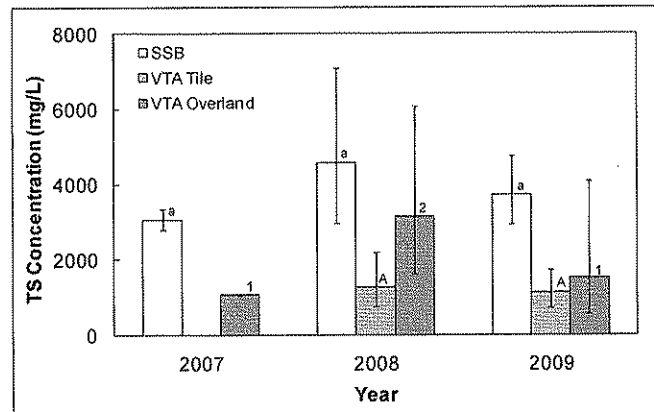
In general, this system was able to achieve moderate levels of treatment averaging 69, 55, 58, 61, and 55% reductions in transport of ammoniacal nitrogen, chemical oxygen demand, total phosphorus, total Kjeldahl nitrogen, and total solids. These results were slightly lower than those a containment basin runoff control system would have achieved under similar weather conditions; however, improvements in system management and operation could have significantly improved performance.

Figure 10. Average annual total solids concentrations for runoff control system components. Lower and upper case letters represent significant differences ( $\alpha = 0.05$ ) between years for solids settling basin and vegetative treatment area effluent concentrations respectively.

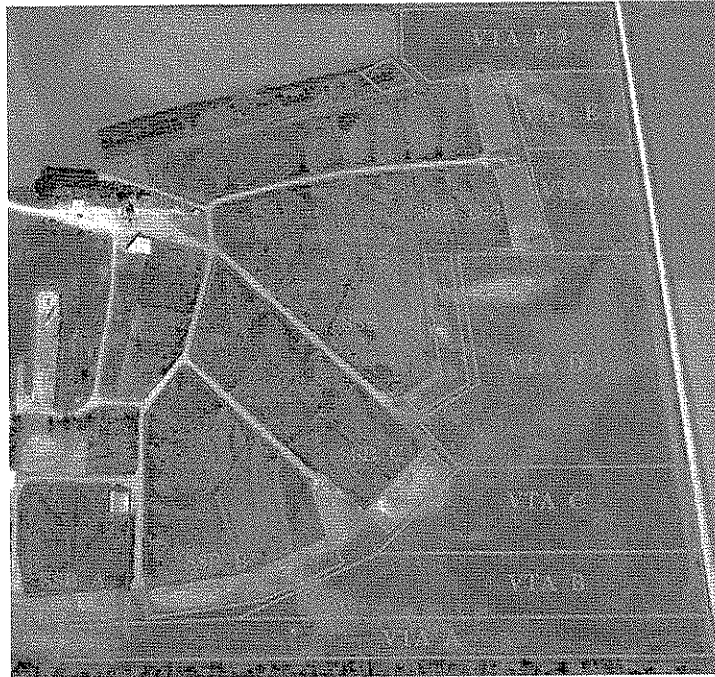
Southwest Iowa 2 had a 3.08-ha earthen feedlot (Figure 11, Feedlot C). Originally this site utilized a settling bench and vegetative treatment system to treat feedlot runoff; the settling bench was replaced with a settling basin in the summer of 2007 (SSB C). The outlet of the settling basin was a perforated PVC pipe surrounded by a porous dam. The pipe ran from the settling basin to a gated pipe located at the top of the VTA (VTA C). A gate valve was installed in the PVC pipe to provide the producer with control over when effluent would be applied onto the VTA. The pilot VTA had an area of 3.5-ha, giving a VTA to feedlot area ratio of 1.1:1. This VTA was constructed with small ridges perpendicular to the length of the VTAs. These ridges slowed the flow of effluent through the system and provided more time for infiltration to occur. A pipe outlet was located at the bottom of the VTA. A gate valve was installed at this outlet. This gate valve was closed between November 1<sup>st</sup> and April 1<sup>st</sup> to prevent outflow from snowmelt; between April 1<sup>st</sup> and November 1<sup>st</sup> the gate valve was left open so that outflow from the VTA could be monitored.

Figure 11. Feedlot and installed runoff control system.
