# Environmentally Sensitive Maintenance on Agricultural Roads to Reduce Nutrient and Sediment Pollution in the Kishacoquillas Watershed

Prepared for the U.S. Department of Agriculture  
Conservation Innovation Grant Program

**FINAL REPORT**

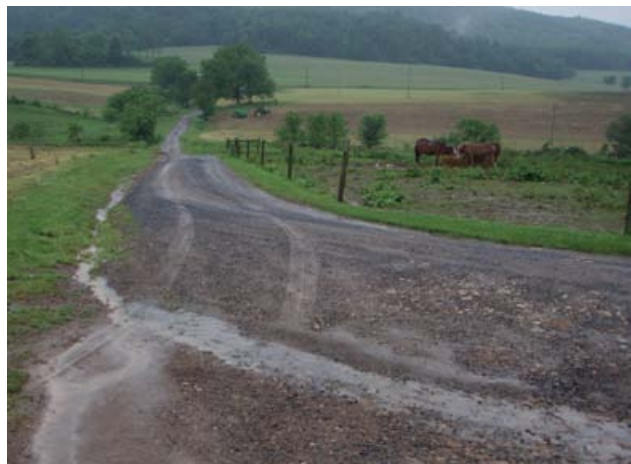
**Figure 1.1:** Many farm lanes act as conduits for sediment and nutrient runoff from nearby agricultural fields to streams.

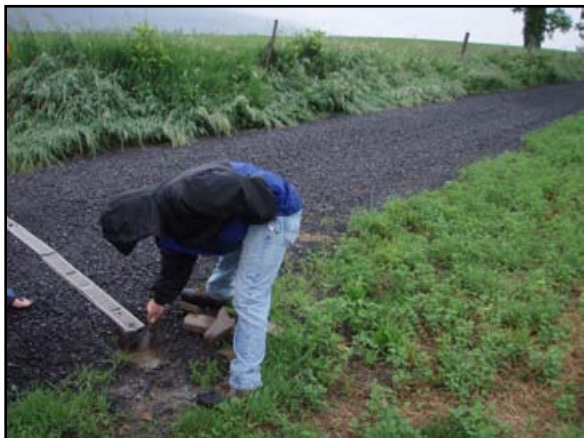
**Figure 3.1:** A sampling point is cleaned in preparation for a storm event after ESM practice implementation on Goss Lane.

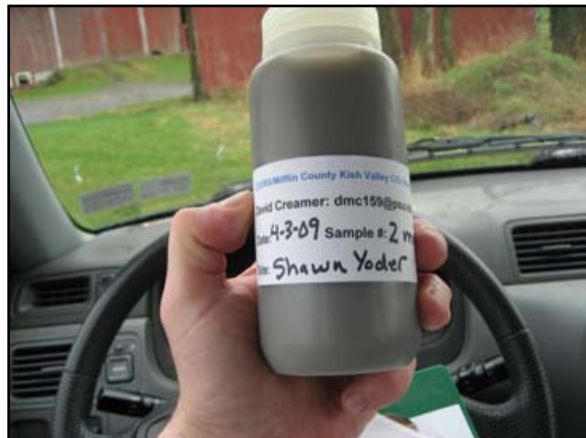
**Figure 3.2:** A sample bottle of runoff, collected and to be analyzed for sediment and nutrients.

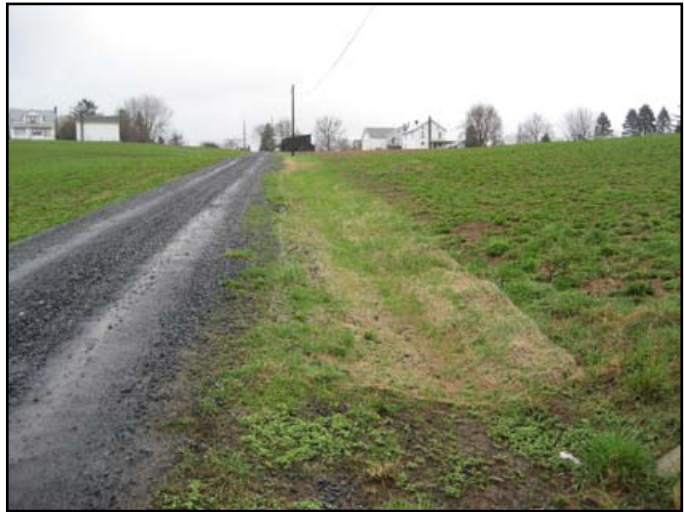
**Pre-Project Problems:** The Yoder farm lane had no drainage control features and had a very poor surface shape (lacked crown). Water from the road and surrounding field was carried on the road surface and directed into the barnyard area. The water was causing erosion and picking up additional nutrients in the barnyard area before continuing past the farm into the stream.

**Figure 4.1:** Grass is beginning to grow through the erosion matting in the newly constructed roadside swale.

**Implemented ESM Practices:** The original plan specified the installation of two new 15" crosspipes, complete with headwalls and endwalls. The intent was to divide the drainage coming to the lane and disperse it as evenly as possible into the surrounding fields. However, the landowner was greatly concerned about any additional water entering the crop fields downslope of the road. A compromise was reached that eliminated the crosspipes in favor of a more traditional approach with an emphasis on

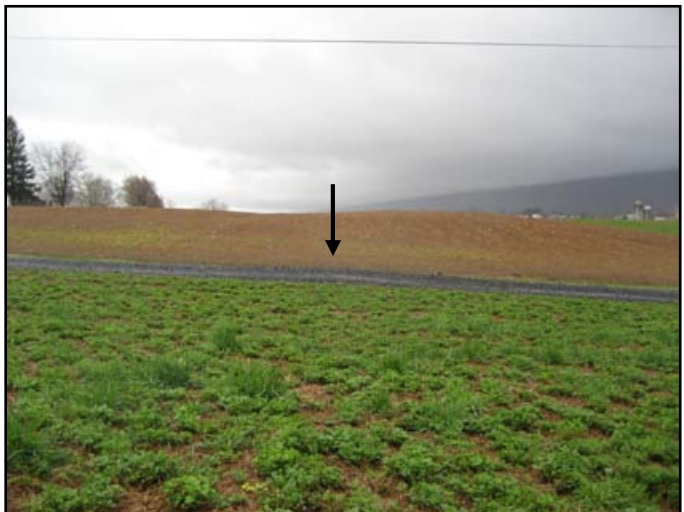
**Figure 4.2:** Although gradebreaks are difficult to see in still images, notice the slight rise in road elevation in the center of the image.

stream and into a stable floodplain is largely responsible for a marked reduction in post project sediment delivery to the stream. This combined with a slight elevation of the road surface and the use of two grade breaks has effectively severed the conduit and now allows field drainage to infiltrate into the ground while also allowing existing vegetation to filter transported sediment.

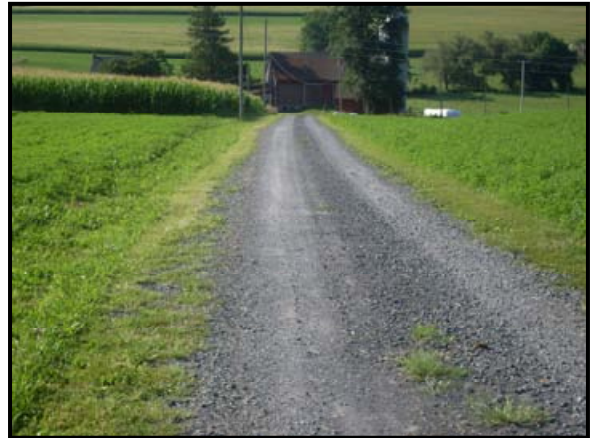
**Figure 4.3:** 2009 image of Yoder Farm lane and grass-lined swale.

Due to the elimination of the proposed crosspipes in the original road plan, the amount of runoff at this site was not noticeably affected as evidenced by a 1% relative increase in volume. However, with the installation of the grass lined swale upslope of the road that intercepts field sheet flow, combined with road surface improvements that shed drainage that previously flowed down the road, a 92% decrease in sediment has been achieved through the use of ESM Practices.

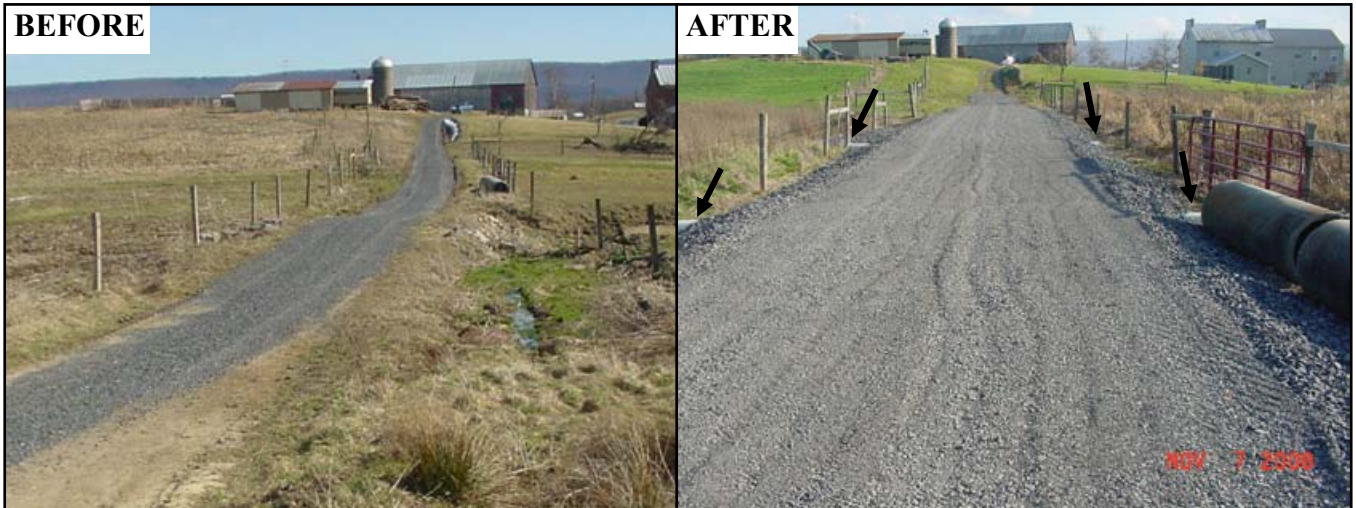
**Pre-Project Problems:** The Goss Farm lane cuts across a small wetland stream channel. The road creates a dam on the channel and funnels the water through two concrete pipes. Because of the large amount of surface and sub-surface water present, the road base in this section of lane is always wet and susceptible to potholes and rutting, resulting in a need for higher than normal re-graveling rates and more frequent surface maintenance. Farm equipment utilizing the road has historically created ruts and disturbed settled sediment, allowing the sediment to then drain with road surface flow. Drainage is carried on the road surface and in roadside ditches until it discharges into the stream near the stream crossing.

**Figure 4.4:** This is the wetland stream crossing on the Goss Farm. Notice that BEFORE, water is dammed up against the right side of the road and funneled through a single pipe. The AFTER picture shows the French mattress. White pipes are visible and highlighted with black arrows. Notice also that the road's "lowpoint" has been moved away from the stream so runoff is forced to leave the road before nearing the channel

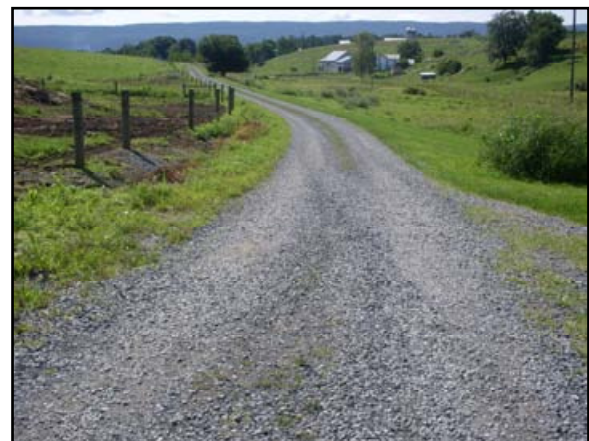
**Figure 4.5:** 2009 image of the improved Goss Farm Lane.

The activities on the Goss Farm clearly have had significant impact on water quality in this study. Before the road project, water emerging from a spring in the adjacent pasture would enter the road way and be conducted directly into the unnamed tributary to Honey Creek. The French mattress installed here allows the flow from the

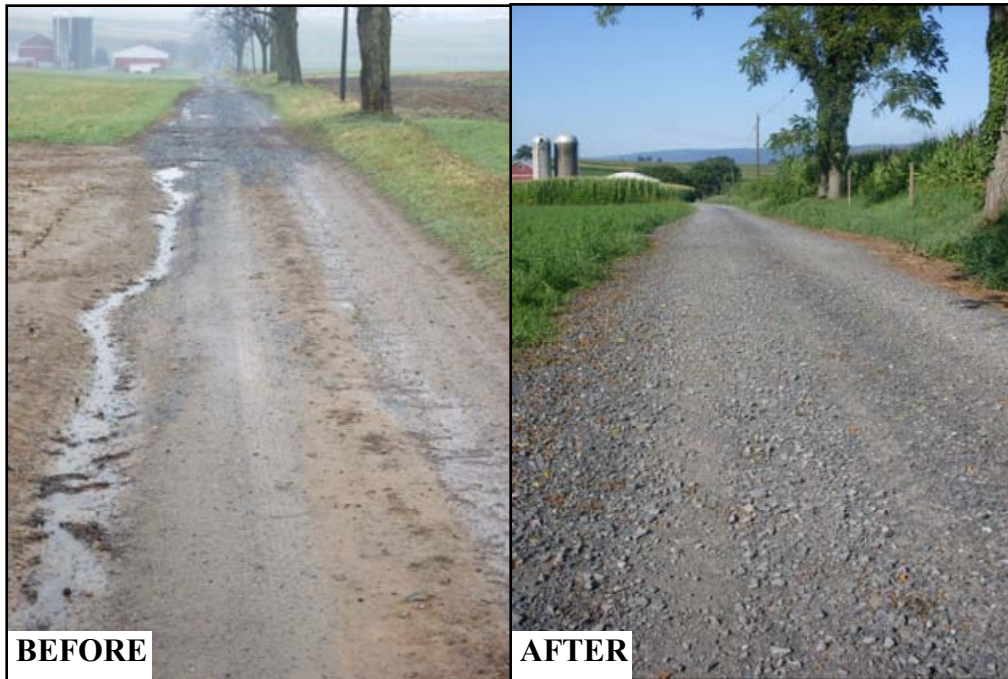
**Pre-Project Problems:** The Stuck Farm lane was the proto-typical “entrenched road” that collected runoff from the surrounding fields, trapped it on the road surface, and transported it down the hill to the stream. This trapped drainage caused constant erosion problems for the landowner in addition to acting as a conduit for nutrients and sediment into the stream.

**Figure 4.6:** BEFORE the project, the entrenched farm lane collected field runoff and transported it down the road surface. Many practices were implemented to elevate the road, encourage infiltration, and insure that runoff could no longer use the road as a flow corridor.

**Implemented ESM Practices:** Several practices were used to prevent water from concentrating on this lane and to encourage sheet flow. A total of 420 cubic yards of shale fill was imported in order to raise the elevation of the entire lane an average of 12” in order that the road was no longer “entrenched.” An additional 6” of PennDOT 2RC aggregate was then used to surface the road. Effective road shape, or cross-slope, was established on the road surface. Center-crown is the predominant shape, although some of the lane was out-sloped. Approximately 600 feet of roadside berm that was restricting sheet flow and confining runoff to the lane was removed to

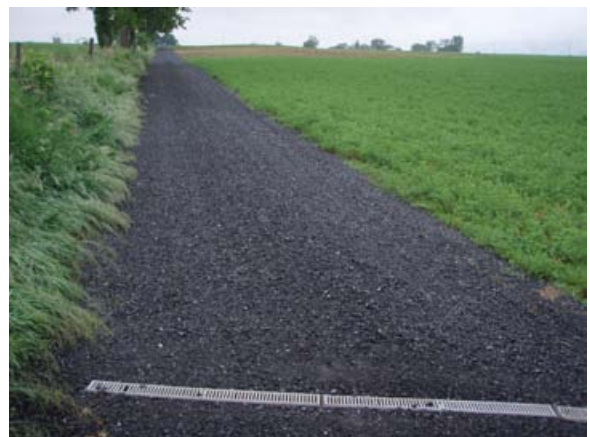
**Figure 4.7:** 2009 image of the improved Stuck Farm Lane.

The drainage patterns on this site were manipulated by using a combination of ESMPs, including raising the road profile, the installation of four broad-based dips, selective berm removal, and outslowing of the road surface at strategic locations. The result was to redirect the field drainage to existing swales and flow paths that required a longer, more subtle meander before reaching the floodplain of the stream. Storm water falling on, or directed to, the road no longer flows on the road and into the stream as was documented prior to the implementation of Environmentally Sensitive Maintenance Practices.

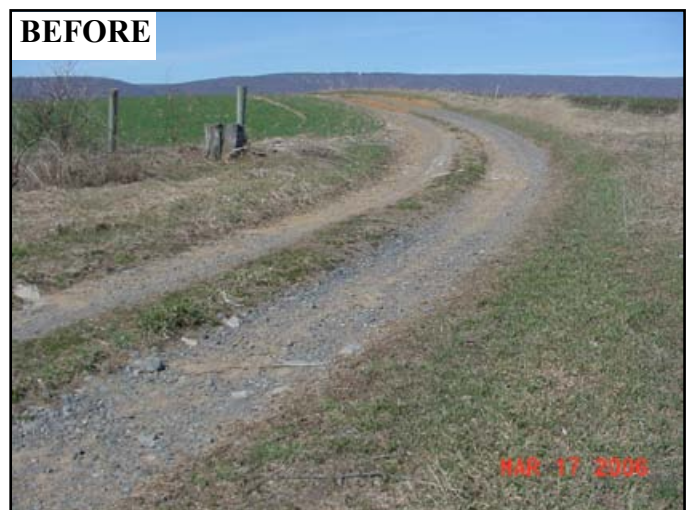
**Figure 4.8:** The existing farm lane with incised wheel tracks.

**Implemented ESM Practices:** PennDOT 2RC aggregate was used to fill and re-profile the incised wheel tracks on the lane.

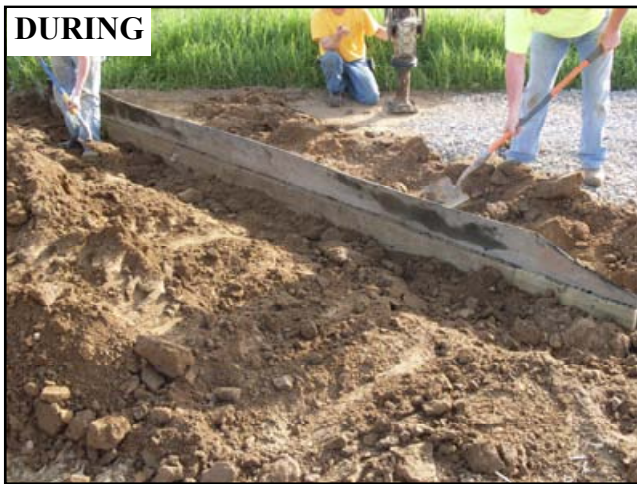
**Figure 4.9:** A conveyor belt diversion is being installed across the road that will allow traffic to pass while diverting water off the road surface.

Geotextile separation fabric was used over much of the lane to reinforce the road base and provide support for a new road surface. In addition the geotextile fabric will help provide weight distribution for regular heavy equipment use. Center-crown was established for the entire project length in order to shed water. Several surface drainage control features were used to insure water would not run down the road surface even if crown was lost. Two conveyor belt diversions were constructed and installed and two broad based dips were also employed to control surface runoff. Stone underdrain was installed to capture a small spring that had been saturating part of the road. The underdrain was directed under the road and outletted into a wooded area.

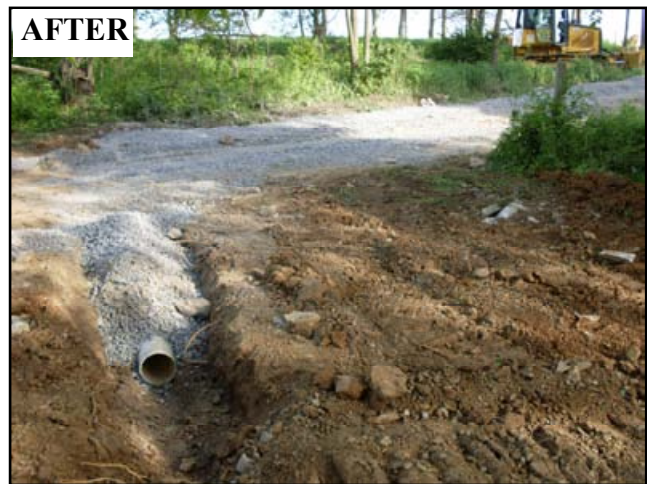
**Figure 4.10:** The outlet of the stone underdrain is shown here just after installation. The underdrain collects clean subsurface water before it enters the road area.

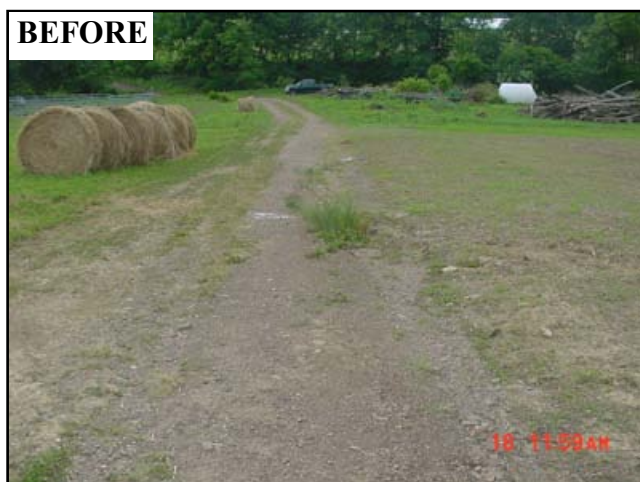
**Pre-Project Problems:** Like many of the other lanes described before, the Snyder Farm lane had become lower than the surrounding fields and acted as an entrenched conduit for field drainage. The road collected runoff from fields on both sides of the stream and funneled it to a ford crossing.

**Figure 4.11:** The existing lane funneled runoff to the stream at the tree line in the background.

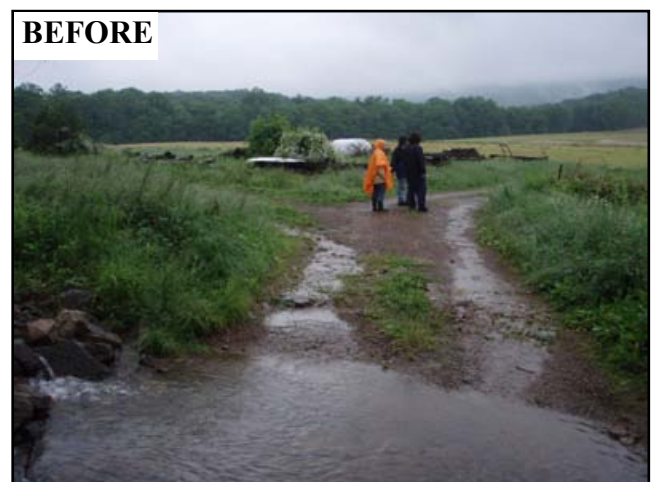
**Figure 4.12:** Farm runoff collected by the farm lane is shown entering a Kish tributary during a rain event.

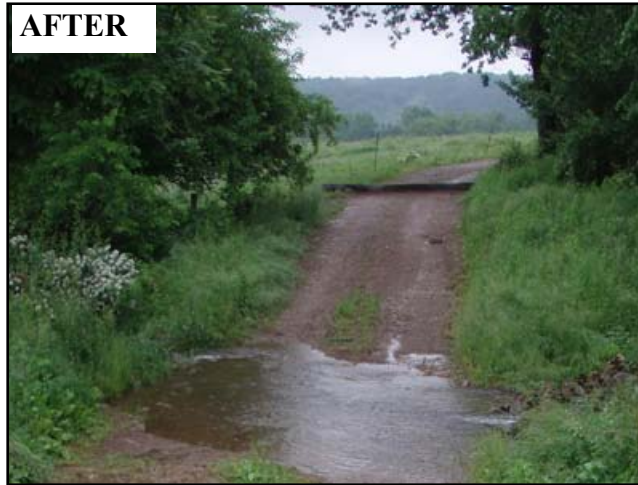
**Figure 4.13:** A conveyor belt diversion, installed before the ford crossing, insures runoff is diverted before it can reach the stream.

**Implemented ESM Practices:** Approximately 400 tons of shale fill were imported and used to raise the elevation of the lane on both sides of the stream. A total of six conveyor belt diversions were installed on both sides of the stream to prevent water from re-establishing former flow channels down the road surface and into the stream. Two broad-based dips were also installed at strategic locations with suitable outlets to further insure water will be diverted from the road area.

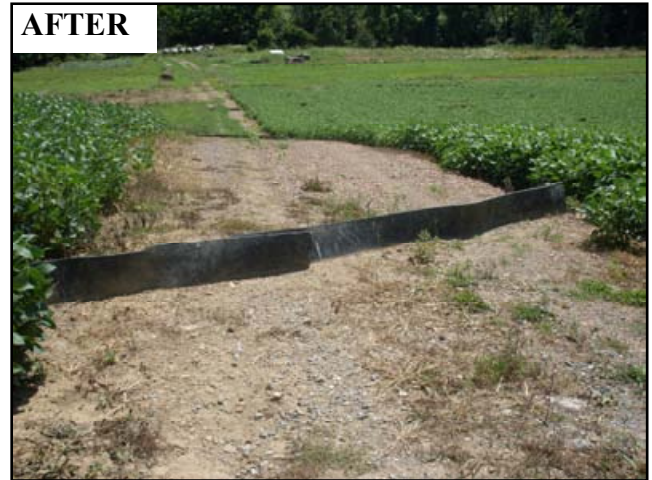
**Figure 4.14:** Three conveyor belt diversions can be seen in series on the hill slope leading to the stream at the tree line.

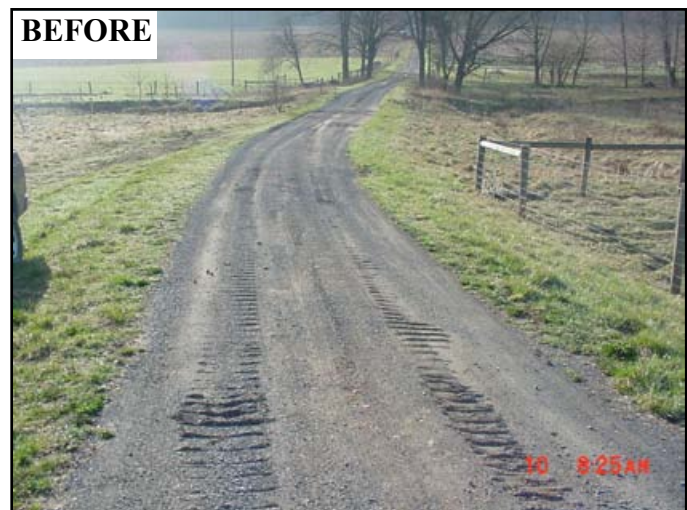
**Figure 4.15:** The existing lane just before construction.

and establish the needed crown. This will result in a more durable driving surface and will provide functional aggregate when doing future maintenance grading. The aggregate was placed on a layer of separation fabric in the flat wet area around the stream crossing to support traffic loads and to keep the quality material from migrating into the soft sub-base. Two grade breaks were

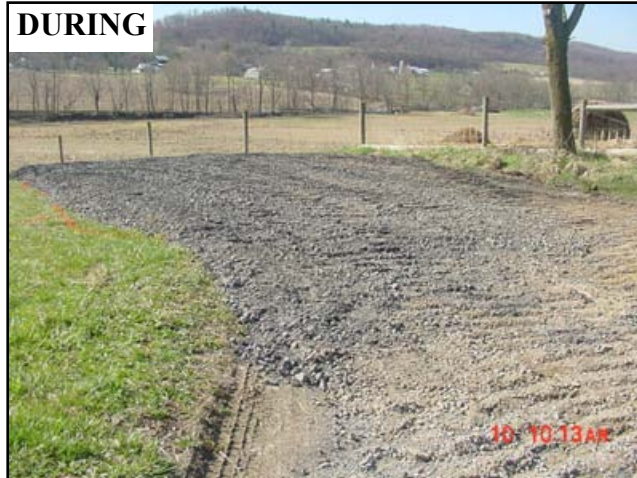
**Figure 4.16:** A broad-based dip is being constructed just before a steep part of the lane. The dip will divert water into the field instead of allowing it to flow down the road.

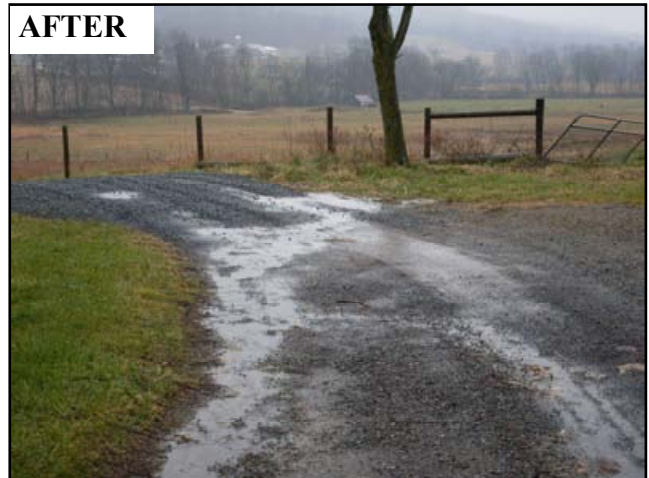
**Figure 4.17:** The same broad-based dip can be seen in action during a rain event.

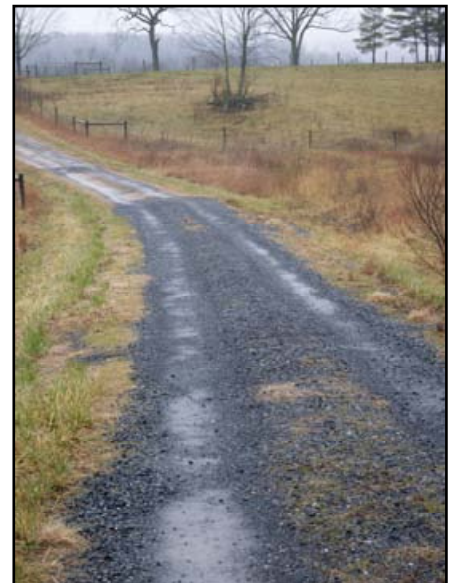
**Figure 4.18:** 2009 image of improved surface and gradebreaks on Pruss Farm lane.

The main focus of the project was to install two grade breaks on the surface of the road to correct the situation and shed storm flow from the road before reaching the stream. A Grade break is a practical surface maintenance structure that creates a relatively short reverse grade on the roadway

which causes drainage to spill laterally off of the road at a predetermine outlet location. The feature is similar to a rolling grade dip routinely used in trail maintenance.

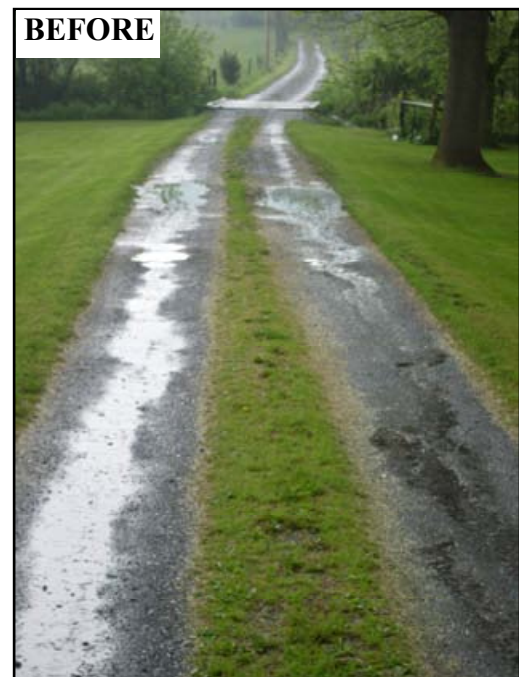
**Pre-Project Problems:** The Filson Farm lane, although relatively flat, still collected water in the road and transported it to the stream. There were no surface drainage features and the road surface was in poor condition. This was a concern of the landowner, as this lane serves as the main access to the public road.

**Figure 4.19:** The existing lane just before construction carries water in the wheeltracks to the bridge in the distance.

**Implemented ESM Practices:** Like the Pruss Farm lane, a few simple practices were employed to improve the road surface and control surface drainage. 2A aggregate was used to establish crown in the road to shed water to the grass area on either side. Two Grade Breaks were installed, one on each side of the stream crossing, to insure that water would not be able to flow down the new road surface and reach the stream. The Filson Farm lane was not used for rainfall sampling.

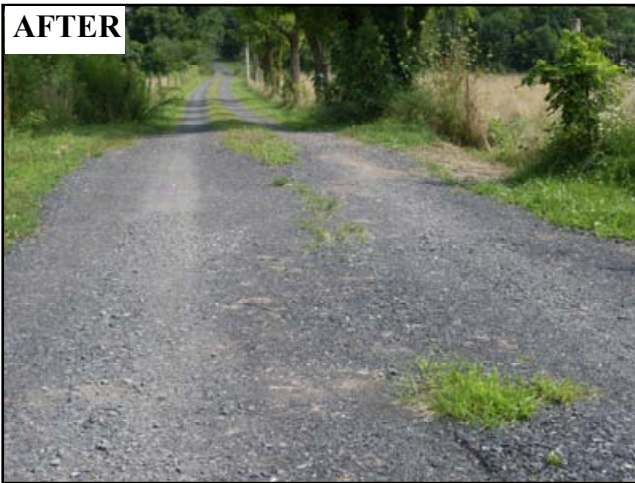
**Figure 4.20:** The gradebreak pictured here sheds water from the road surface, preventing it from flowing to the bridge and stream in the background.

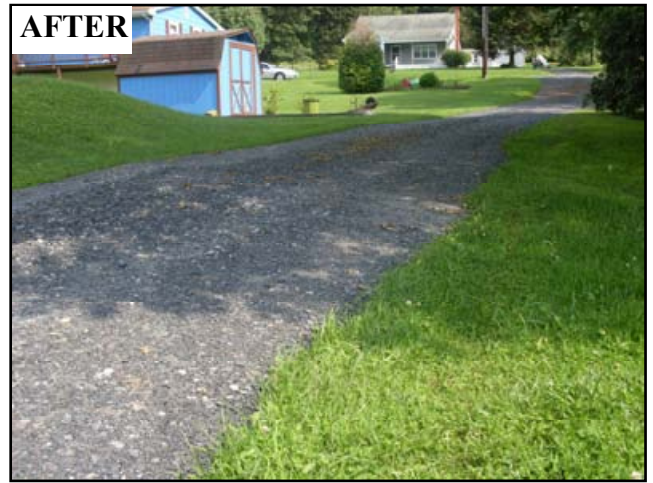
**Figure 4.21:** The improved road surface has a good shape and is resistant to traffic and erosion.

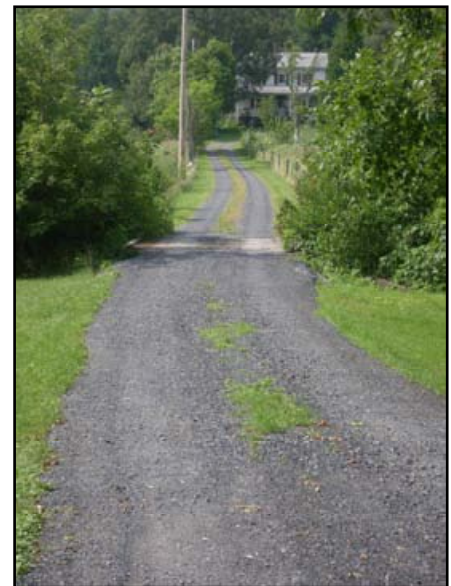
**Figure 4.22:** 2009 image of the improved surface and bridge on Filson Farm lane.

No rain event sampling was performed at the Filson Farm. However, the landowner granted permission to do a project at this site during the initial site selection phase. Therefore, ESMPs were installed on the lane as a reserve site in the event that unforeseen circumstances prevented data collection from any of the other project sites. Five hundred and ten feet (510') of farm lane was included in the project area. Environmentally Sensitive Maintenance Practices were incorporated on the road on both sides of the stream crossing. 2A aggregate was used to rebuild the road surface and provide material to reshape the crown and then be able to maintain in the future. Broad based dips were constructed to direct water across the lane and Grade Brakes were installed to assure that water would no longer follow the wheel tracks increasing the effective life of the crown. Considering that the surrounding land use was either maintained yard or permanent pasture, the project was very effective at reducing road sediment loss to the stream. Prior to the project the area around the wooden bridge surface was severely eroded. Since the road surface drainage features were installed the area around the bridge is very stable with little aggregate loss.

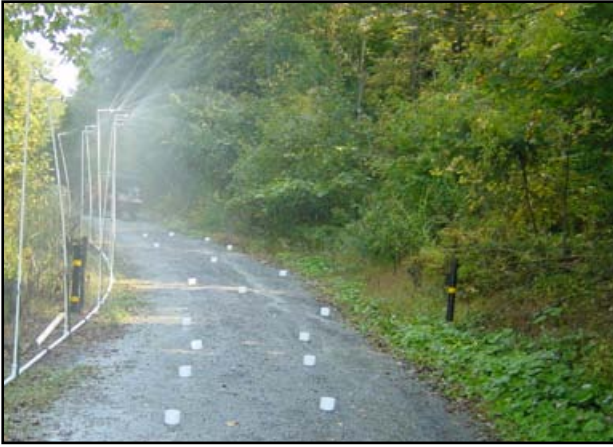
Figure A2: Collection jars for repeatability testing on a test road in Huntingdon County.

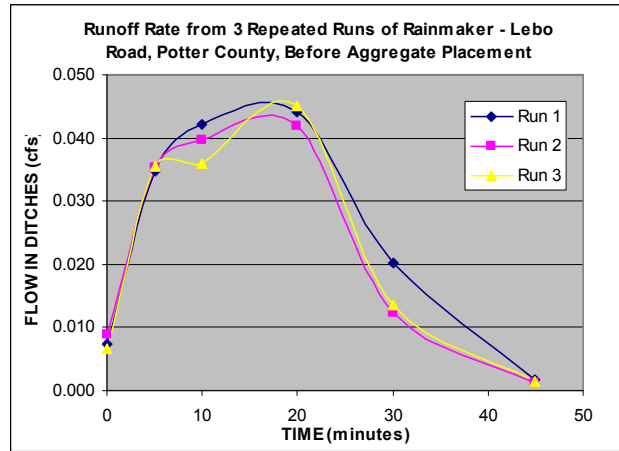
Figure A3: Example of repeatability of rainfall events. The ditch flow from three separate events are shown for Lebo Road in Potter County.

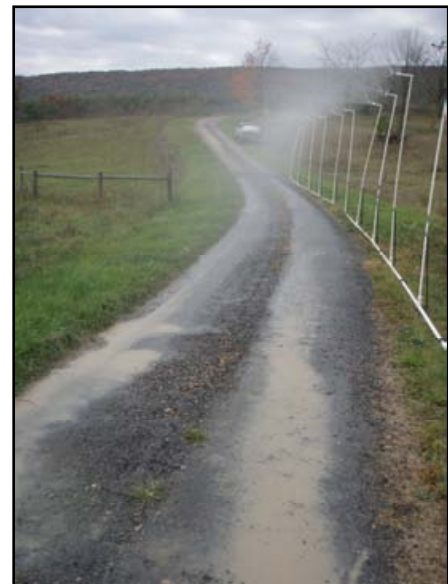
Figure A4: The rainfall simulator being run on Pruss Lane in Mifflin County.

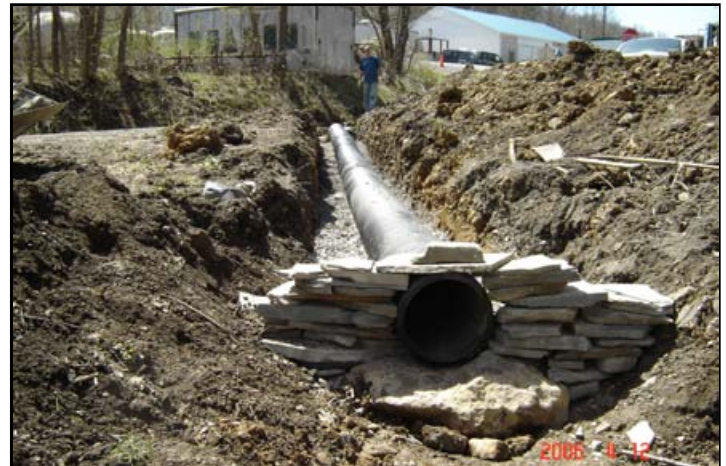
Photo 1. A plastic crosspipe is shown during installation. Notice the pipe bedding material, endwall, and stone at outlet.

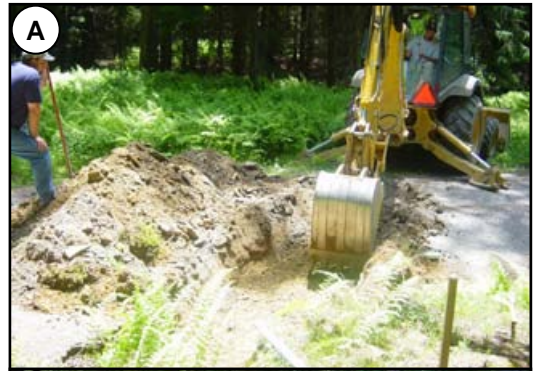
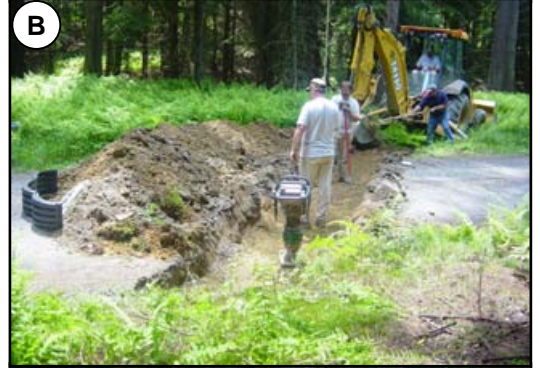
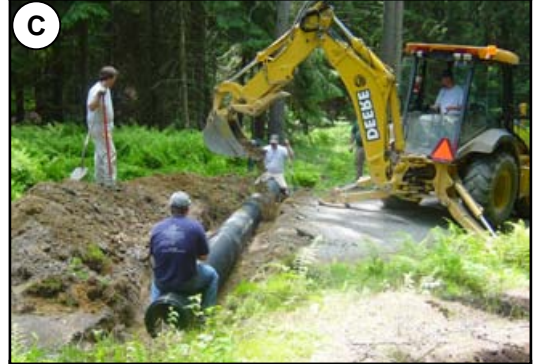
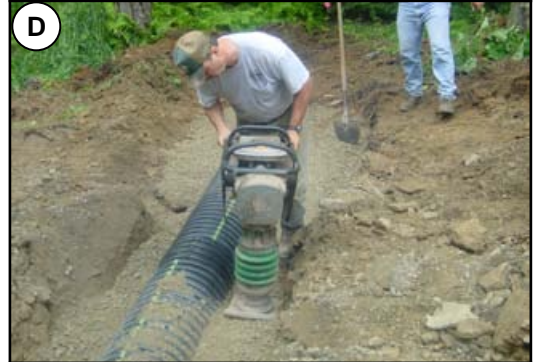
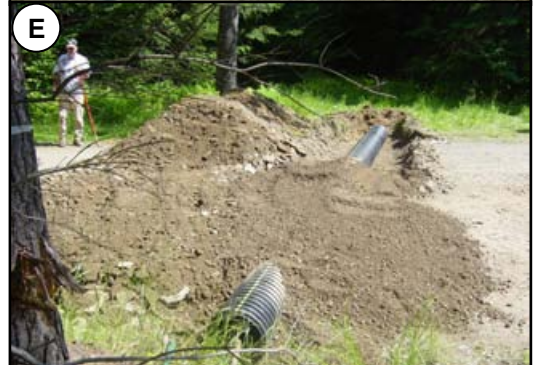
- 3) Place Pipe in Trench:** Place and align first section of pipe in trench. Pipe inlet should be located in the existing ditch line, with just enough room between the pipe and the bank for a headwall. Inlets that are too close to the road pose traffic hazards. Inlets that are too far off the road cause unnecessary bank erosion. Align additional pieces and secure together using provided collars or pipe adhesive. Look under pipe to make sure it is in constant contact with the bedding. Voids under the pipe will cause sagging upon compaction. If desired, headwall and endwall can be constructed at this time. Fill will be placed against the back of the walls in next step (*See photo 1 on front*). Otherwise, headwall and endwall can be constructed after pipe installation is complete.

- 4) Place and compact fill material around pipe:** Place bedding material around pipe until approximately 8" of material is on each side of pipe. Pipe may need to be held in place so fill material does not push or lift pipe (*See photo C*). Use a Jumping-Jack to compact fill on both sides of pipe. Compaction of the first layer of bedding material is crucial because it packs material down around the base of the pipe for support (*See photo D*). The importance of compaction cannot be overstated! Unlike metal and concrete pipes which have structural strength, plastic pipes get their strength from the material compacted tightly around them. Be careful not to puncture pipe with the foot of the Jumping-Jack while compacting. Continue to fill and compact in stages, placing approximately 8" of fill before compaction. If too much fill is placed at once, proper compaction cannot be achieved. Continue to fill and compact over top of pipe (*See photo E*). Be sure to provide adequate fill over pipe. Adequate fill varies with pipe size and construction. Plastic pipes up to 24" in diameter require a minimum of 12" of compacted cover.

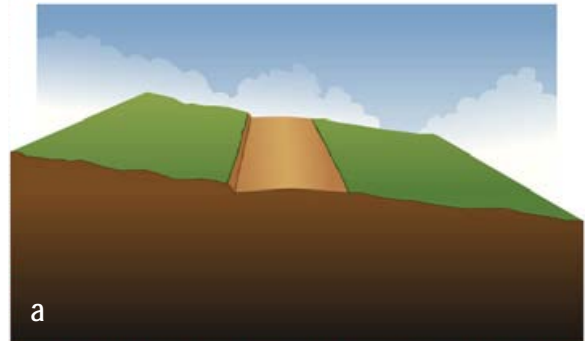
Over time, natural erosive forces, vehicle traffic, and routine maintenance practices can transform the road's original profile (a) into a deeply entrenched road (b) that is difficult to maintain without causing further soil erosion and increased maintenance costs.

Routine road maintenance practices (surface grading, snow removal, shoulder cutting, ditch cleaning, etc.) combined with the wear and tear of traffic and natural erosive forces have the cumulative effect of lowering the elevation of the road in relation to the surrounding terrain. As the road profile drops, water draining to the road is trapped and concentrated in parallel ditches and the road begins to function as a channel for downslope water flow (see image b).

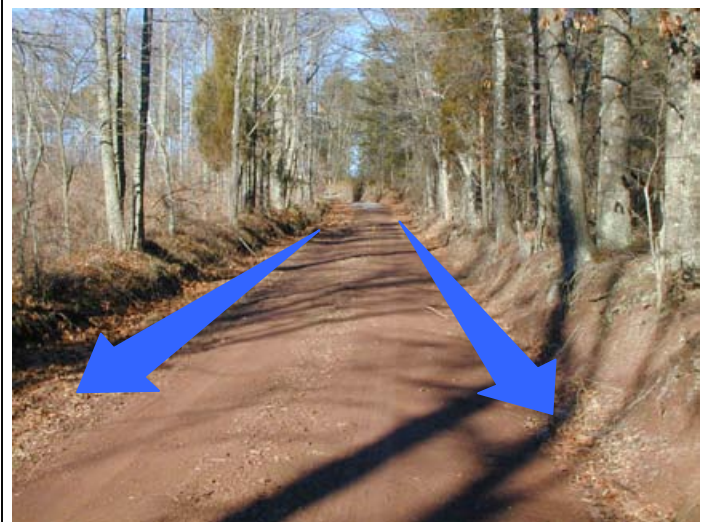
This deeply entrenched road traps drainage and is a persistent source of maintenance and erosion. Additional maintenance efforts and vehicle traffic compound the problem by lowering the road elevation further.

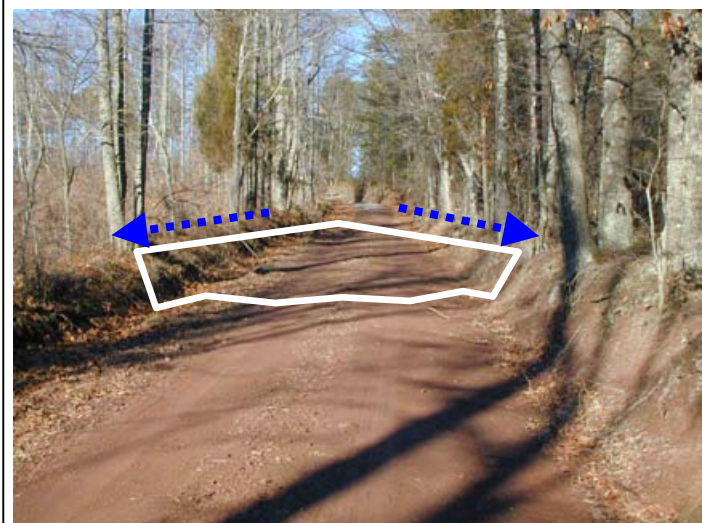
Filling the road profile here, as shown above, with appropriate center-line crown, eliminates concentrated parallel ditchflow and allows water to sheet flow off the road into surrounding terrain, reducing the erosive force of “hungry” water and saving scarce maintenance funds.

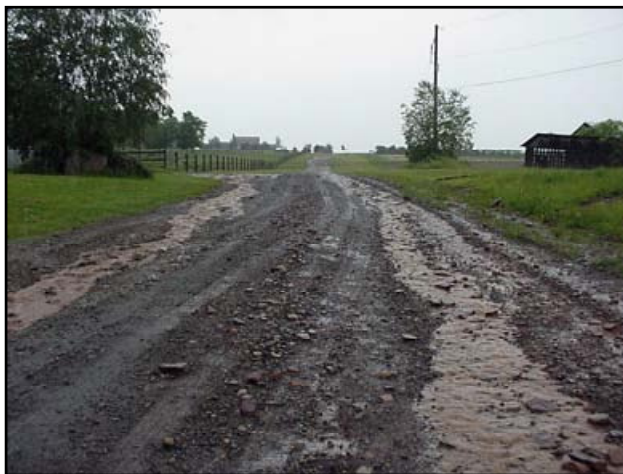
NO GRADE BREAK – Water flows on road causing excess erosion and aggregate loss.

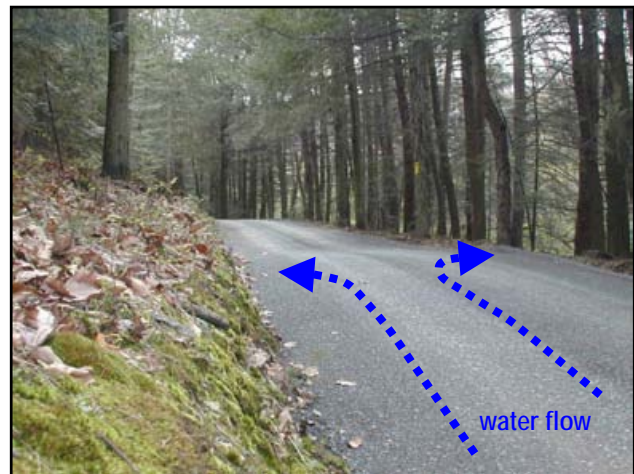
GRADE BREAK – Interruption in slope redirects flow and causes water to leave road area.

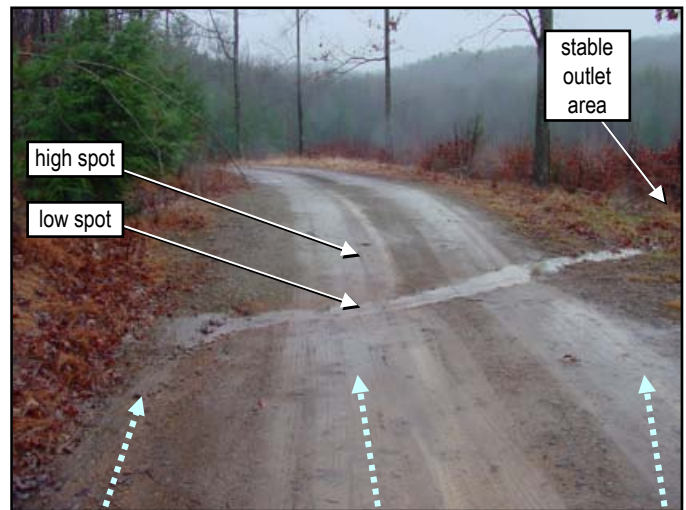
This *broad based dip* in Huntingdon County is located on an access road that is only open to the public for hunting season. This low-use road is ideal for *broad based dips* instead of crosspipes to reduce long term maintenance. The dip pictured here collects road and ditch water and directs it from left to right across the road.

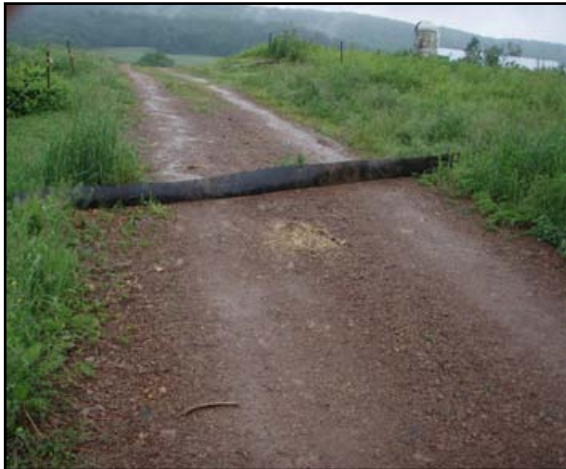
Completed Conveyor Belt Diversion

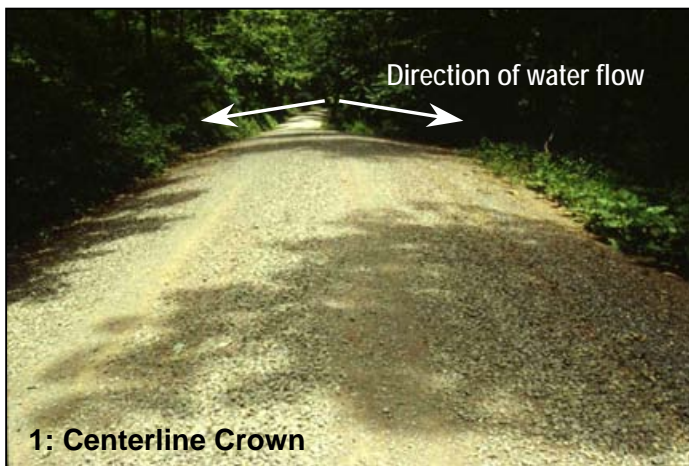
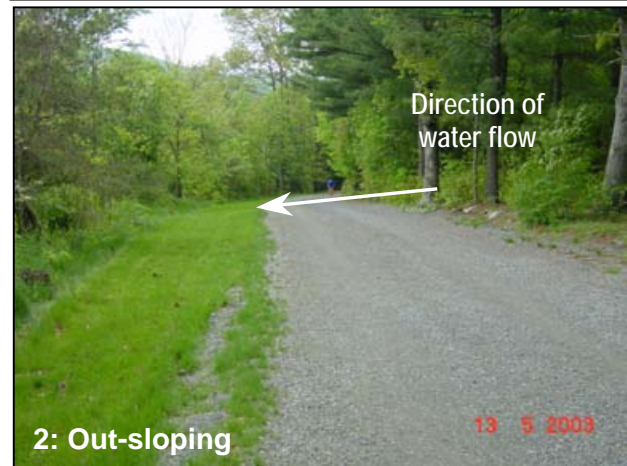
1. **Centerline crown:** A surface configuration that sheds water to both sides of the road from its longitudinal highpoint (1).
2. **In-sloping:** This surface configuration drains water from the entire width of the road toward the cut-bank or up-slope side. Commonly used on steep side-hills or where speed requires a banked curve, in-sloping can be useful to direct ditch water to better discharge points and also to lessen the probability of vehicles sliding on a steep side-slope.
3. **Out-sloping:** Out-sloped road surfaces drain water from the entire width of the road toward the fill-bank or down-slope side. The road is shaped to avoid collection or concentration of water in a ditch. Minor overland sheet flow is allowed to flow across the road (2). Out-sloping is useful on roads where concerns about winter icing are minimal or side-slopes are gentle.

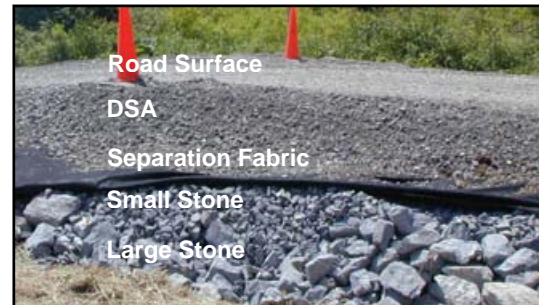
Side view of an actual French mattress.

**PURPOSES:** The primary function of a *French mattress* is to provide load support and to establish, maintain, or equalize the subsurface water on both sides of the road. The use of *French mattresses* in road maintenance is a relatively new concept. Please contact the Center for Dirt & Gravel Road Studies with any questions or concerns.

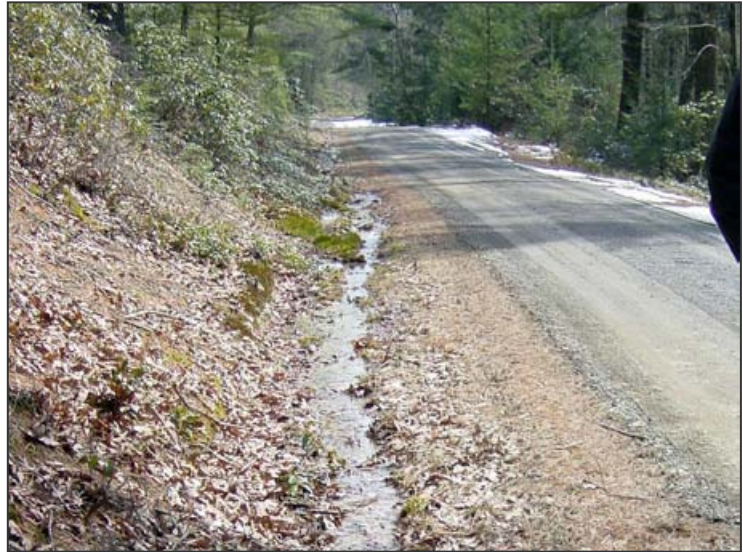
The ditch above carries water from roadside springs. An underdrain can collect this flow to keep the roadbed and ditch dry.

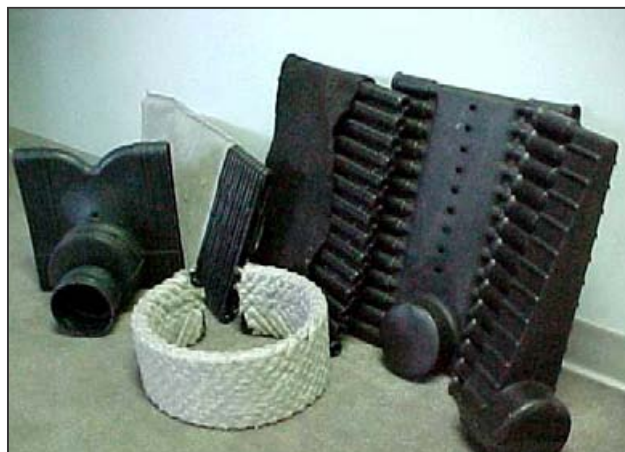
Prefabricated underdrains come in a variety of shapes and sizes.

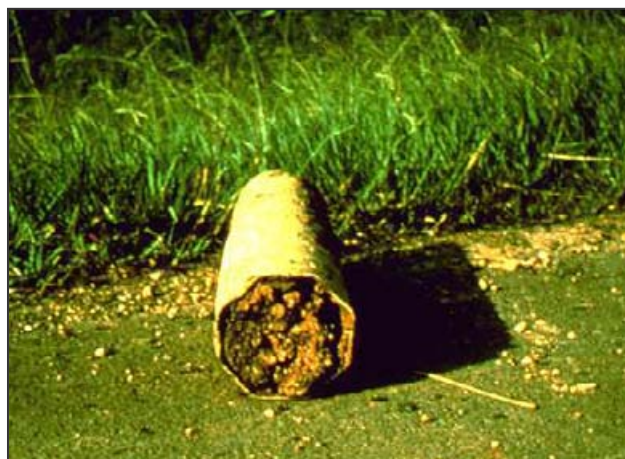
Fabric and outlet protection are important to prevent clogged pipes such as this.

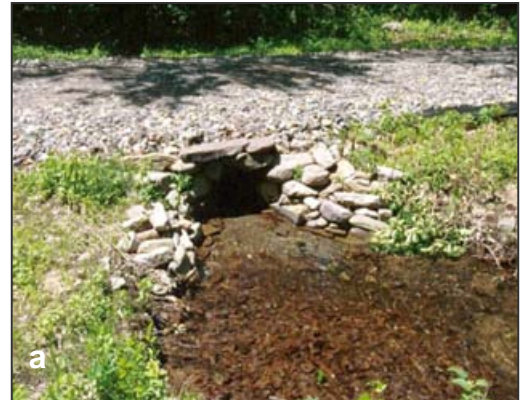
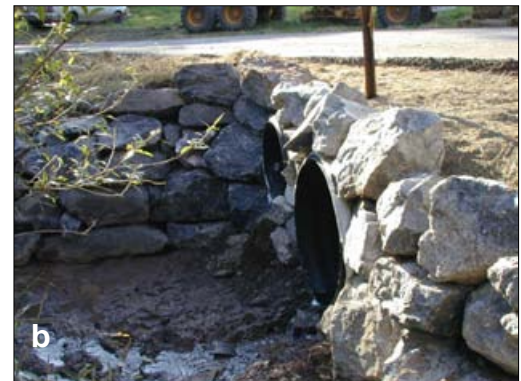
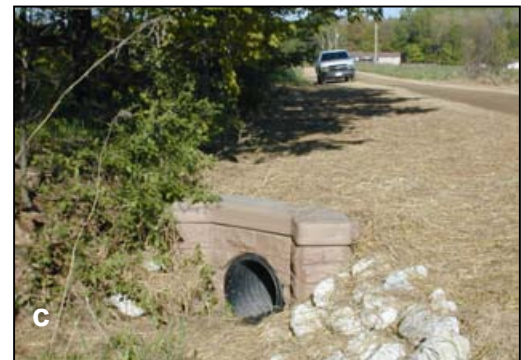
Walls can be made with a variety of materials including native stone (a), boulders (b), or molded plastic (c).

- Native stone or boulders collected on-site
- Pre-cast concrete and cast-in-place concrete
- Molded plastic (Hartman Endwall System)
- Modular masonry products

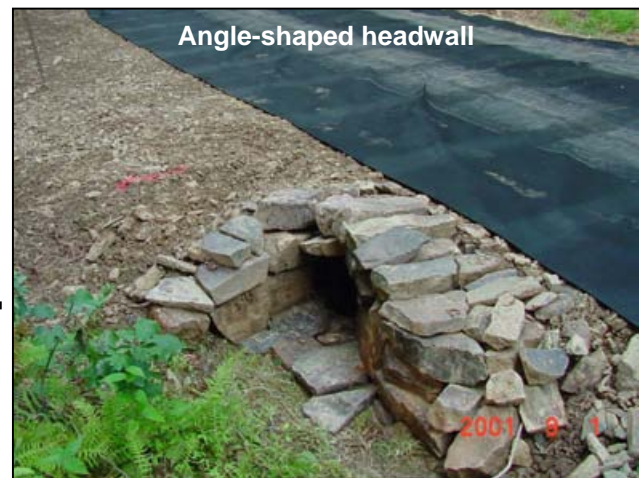
Figure 3: Longitudinal Section of Pipe Installation.  
The head- and endwalls are built 12" above the pipe to ensure proper cover, support the road, and improve pipe capacity.

- Headwalls and endwalls should be built high enough to support the full depth of pipe cover recommended by the manufacturer: 12" of cover for plastic and corrugated steel pipe 24" in diameter and smaller (Figure 3).
- It is critically important to anticipate the forces of drainage water under heavy storm high flow conditions. Drainage structures should be built to conduct massive flows and provision for safe over flow should be provided. Headwalls and end walls built to the proper height not only improve pipe capacity during extremely high flows but also help prevent pipe blockage, road washouts and the resulting catastrophic effects.

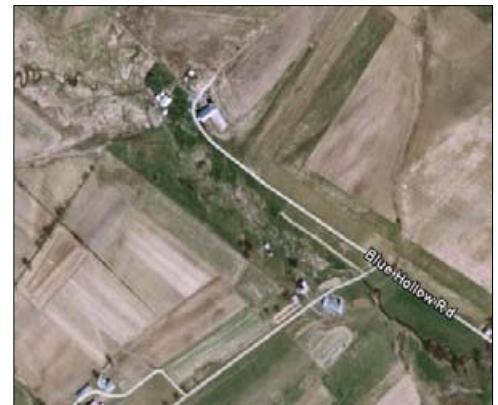
**Figure 1:** This is the wetland stream crossing on the Goss Farm. Notice that BEFORE, water is dammed up against the right side of the road and funneled through a single pipe. The AFTER picture shows the 120 foot French mattress. White relief pipes are visible and highlighted with black arrows. Notice also that the road's "lowpoint" has been moved away from the stream so runoff is forced to leave the road before nearing the channel. The Broad based dip at this location forces the water to the down slope side of the road.

**French Mattress:** Similar to a French Drain used for home construction, a French Mattress consists of clean stone wrapped in water permeable separation fabric. The mattress is used in particularly wet areas and is placed under the road to provide support for the road while allowing the free movement of water through the road base.

**Broad-Based Dip:** A broad-based dip is a wide and shallow channel with an associated high spot that forms a reverse grade. The dip functions in a fashion similar to a grade break to prevent water from flowing down the road. However, the dip is installed diagonally across the road and differs from the grade break in that it collects drainage from the full width of the road and transports the water to a single outlet point. These structures function similar to crosspipes to outlet and disperse ditch flow from the road corridor. The bottoms of dips are typically reinforced to prevent erosion.

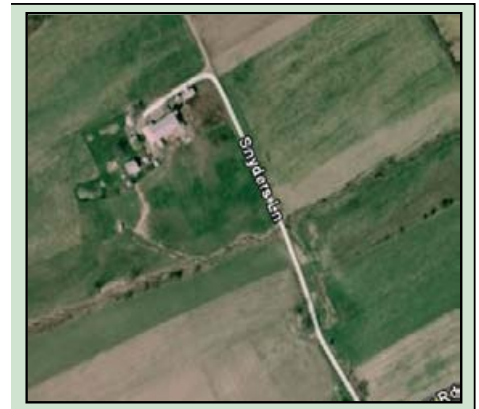
**Figure 1:** The existing lane funneled runoff to the stream at the tree line in the background.

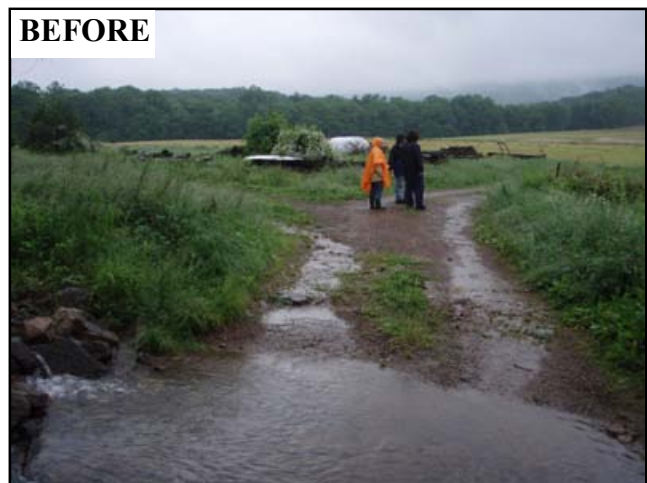
**Figure 2:** Farm runoff collected by the farm lane is shown entering a Kish tributary during a rain event.

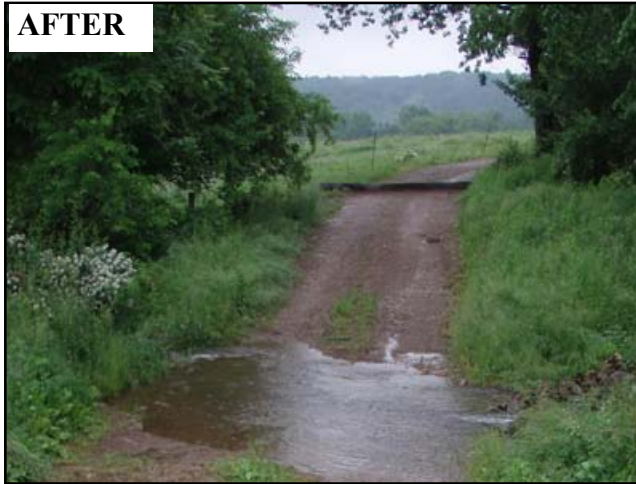
**Figure 3:** A conveyor belt diversion, installed before the ford crossing, insures runoff is diverted before it can reach the stream.

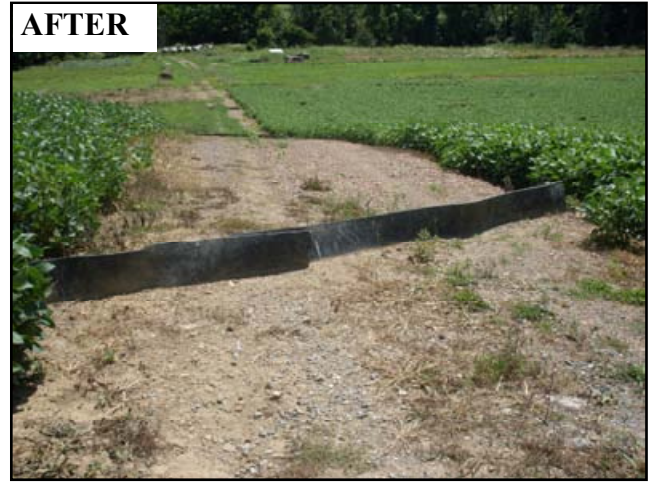
**Figure 4:** Three conveyor belt diversions can be seen in series on the hill slope leading to the stream at the tree line.
