# Environmentally Sensitive Maintenance on Agricultural Roads to Reduce Nutrient and Sediment Pollution in the Kishacoquillas Watershed

Prepared for the U.S. Department of Agriculture  
Conservation Innovation Grant Program

**FINAL REPORT**

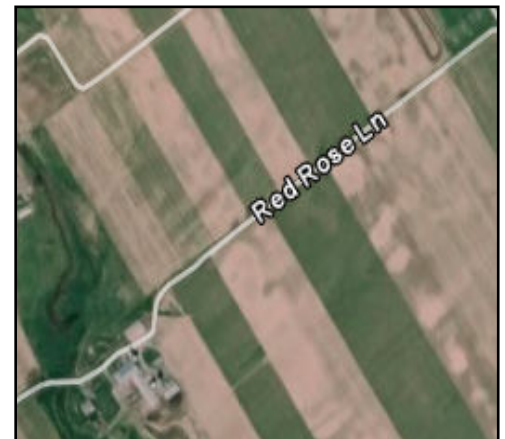
**Figure 1&2:** BEFORE the project, the entrenched farm lane collected field runoff and transported it down the road surface. Many practices were implemented to elevate the road, encourage infiltration, and insure that runoff could no longer use the road as a flow corridor.

**Berm Removal:** In some areas small amounts of topsoil along the down-slope road edge (generally less than 6" in depth and no wider than 3') were excavated and redistributed over higher ground in the fields, so road drainage would not be restricted from draining to lower ground.

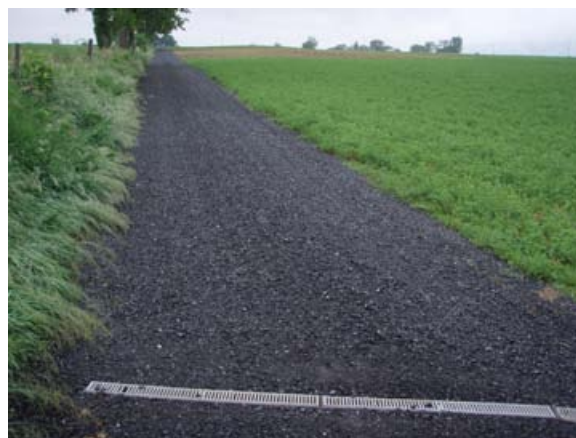
**Figure 3:** 2009 image of the improved Stuck Farm Lane. In the lower portion of the photo is a sampling trench.
