## *Conservation Innovation Grants Adoption of a Rapid, Direct Measure Device to Measure Specific Discharge from Earthen-Lined Waste Storage Ponds*

Prepared for:  
USDA-NRCS

**RE: Grant Agreement NRCS 68-3A75-6-135  
Final Report**

## CONSERVATION INNOVATION GRANTS FINAL REPORT

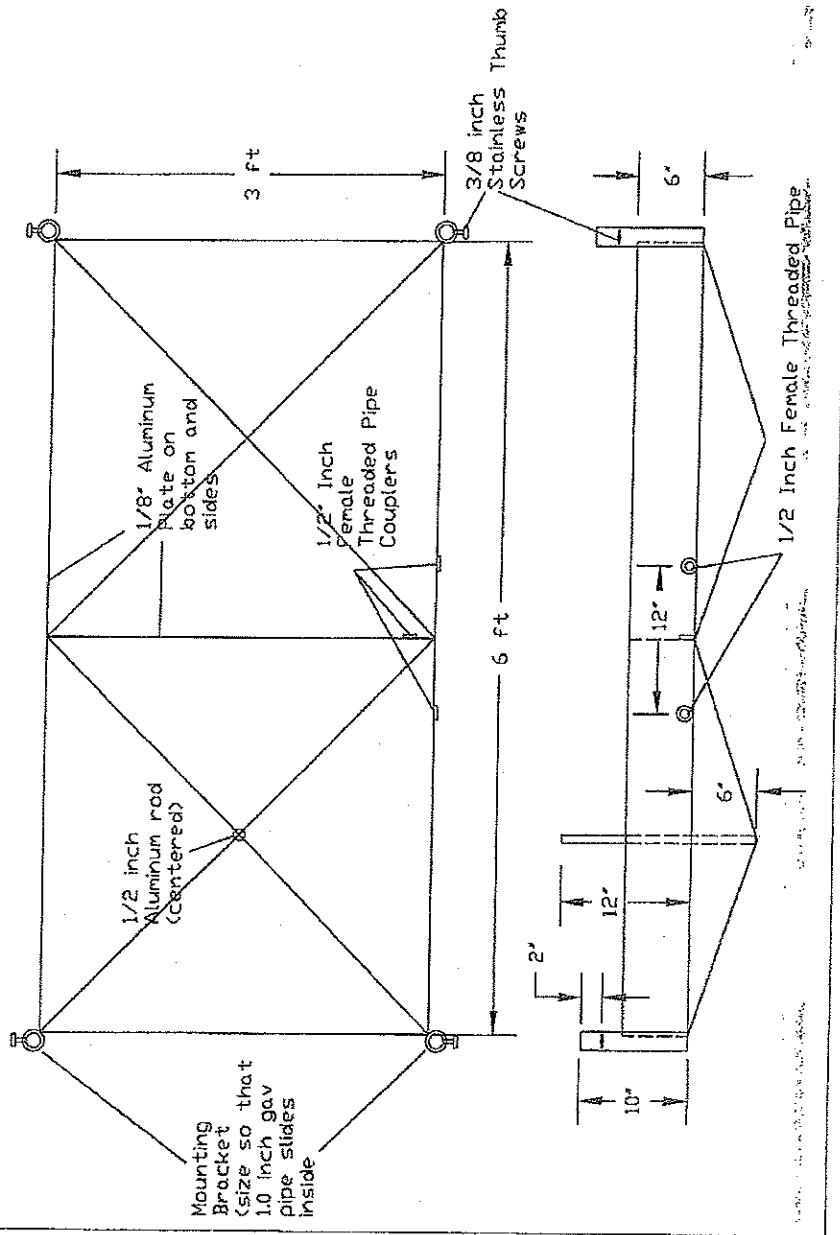
1A

Monitoring Pan  
Plan and Profile

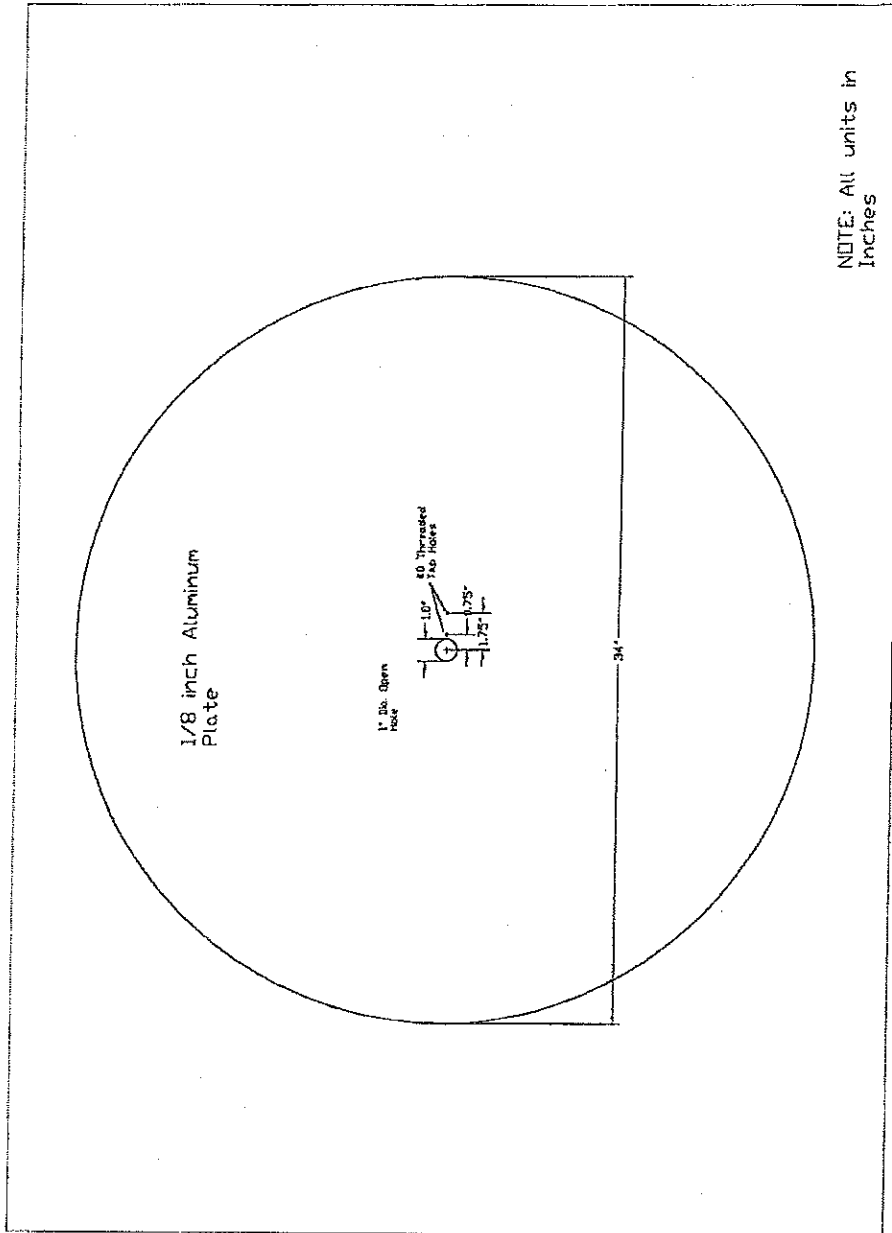
2A

Float Plate  
Plan View

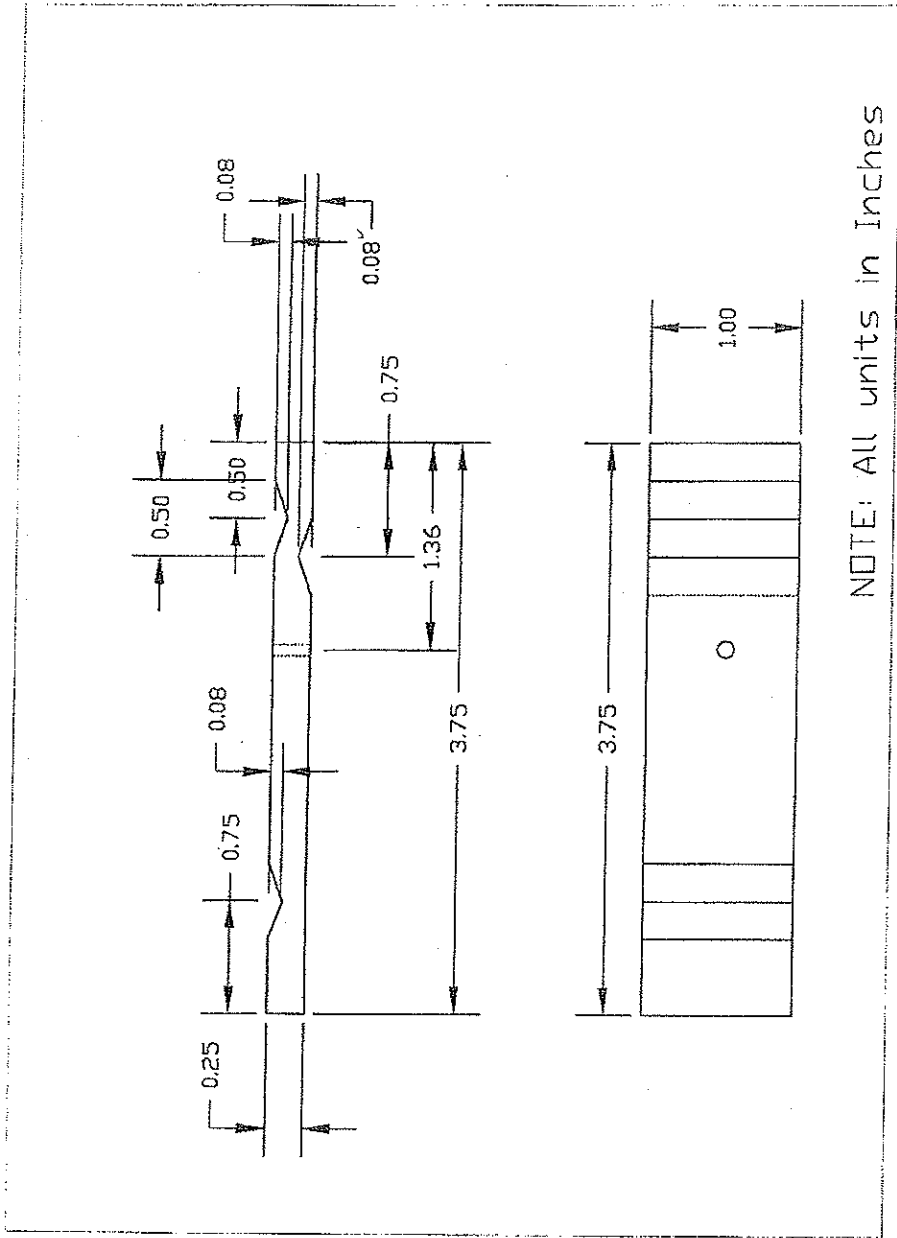
3A

Mirror and Focum Plate  
Plan and Profile

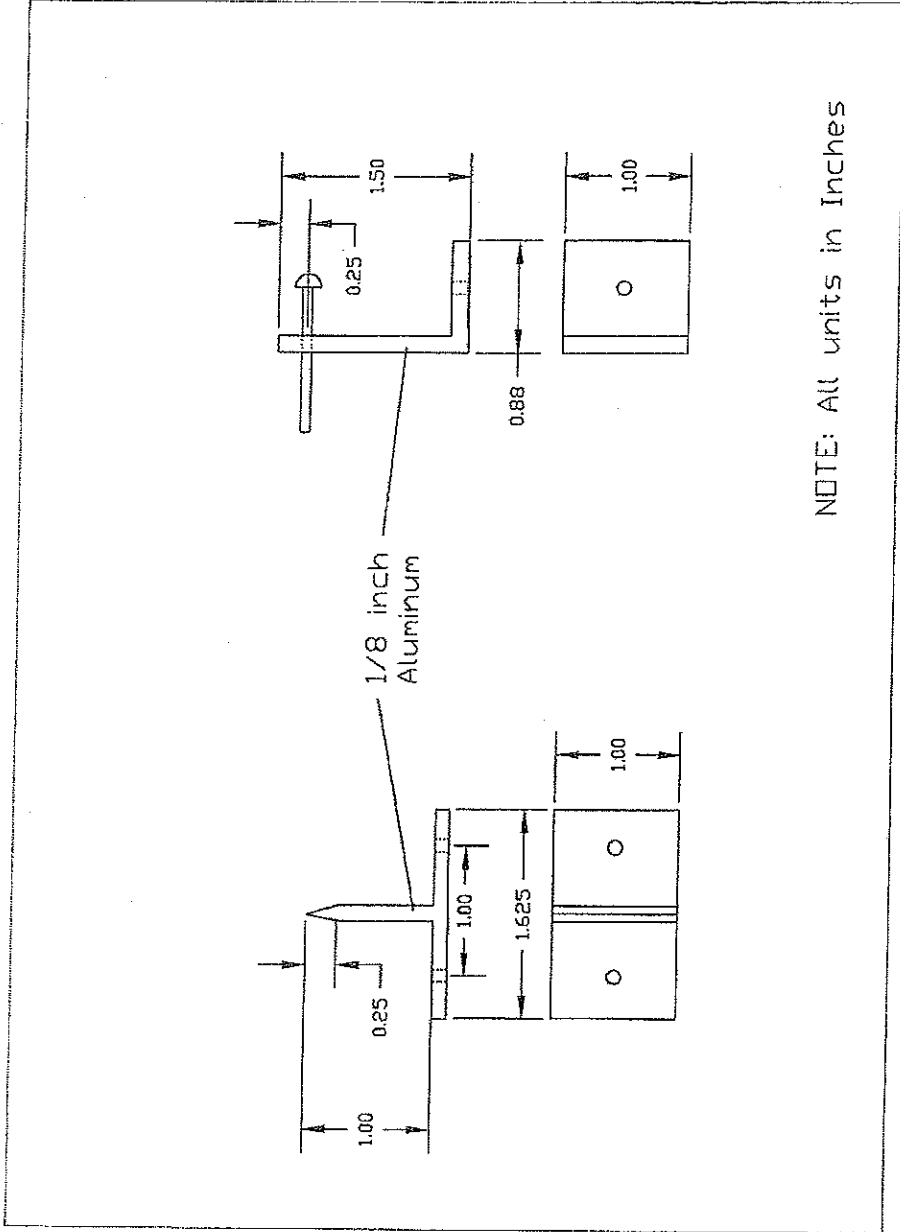
4A

Bottom Blade w/ Mounting Bracket,  
plus Mirror Mount

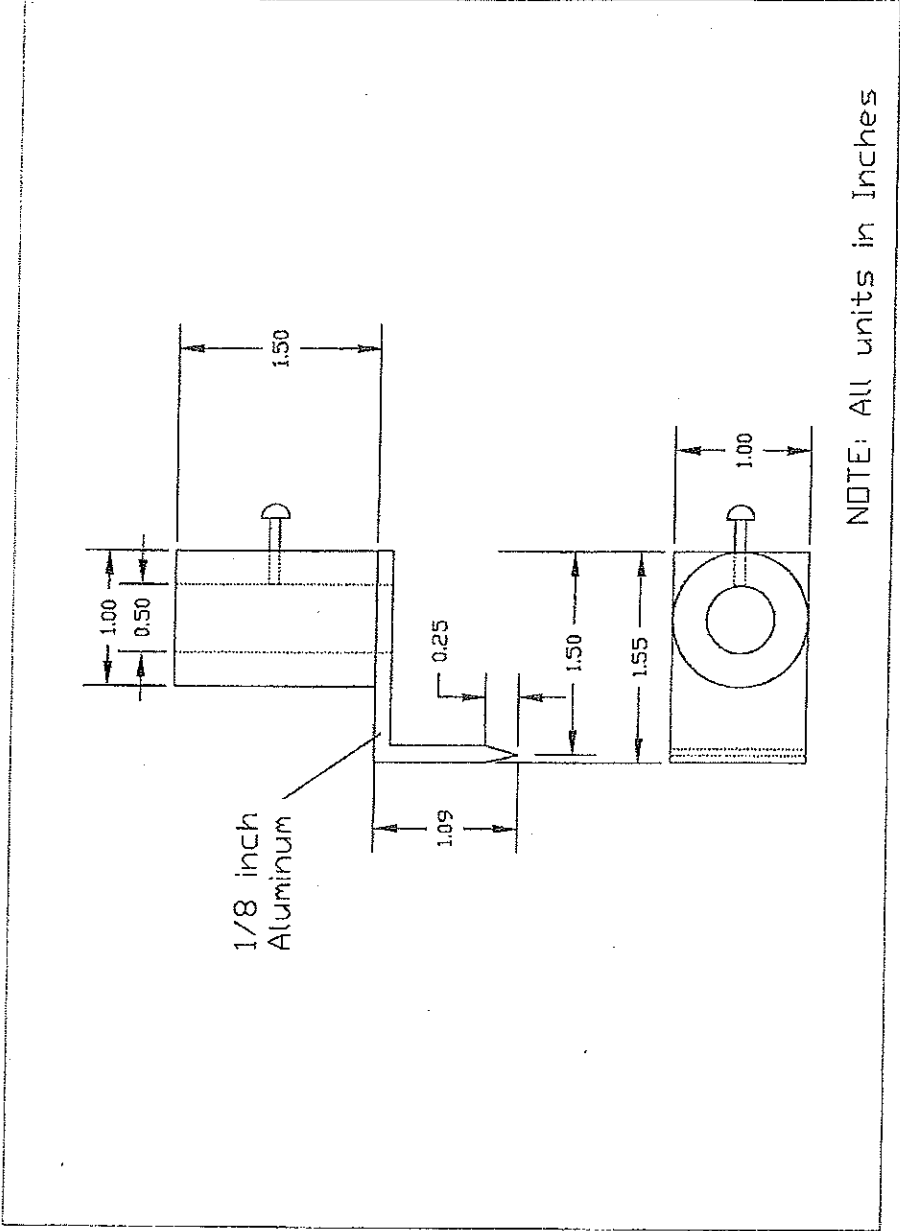
5A

Top Blade and Mounting Bracket

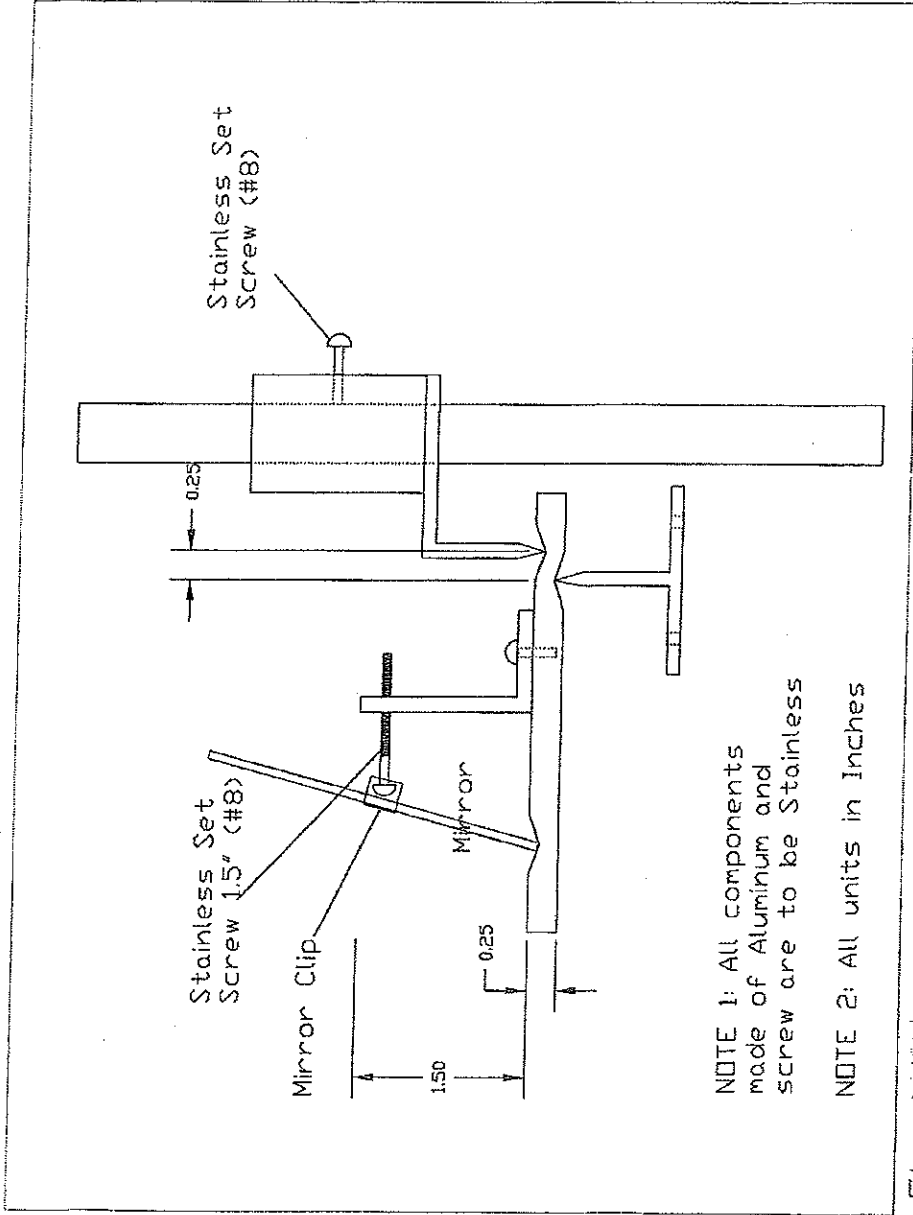
6A

NOTE 1: All components made of Aluminum and screw are to be Stainless

Float/Mirror Measurement Apparatus

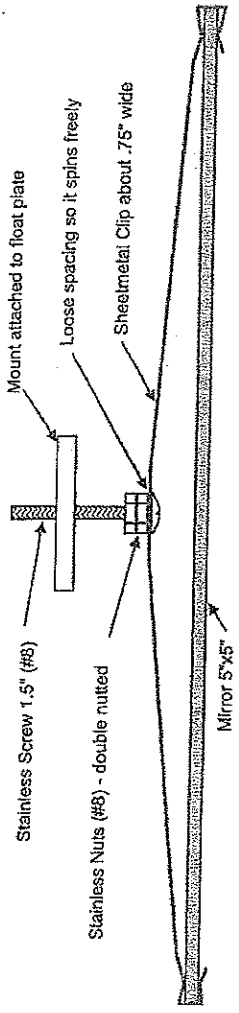
7A

Mirror Mounting Bracket

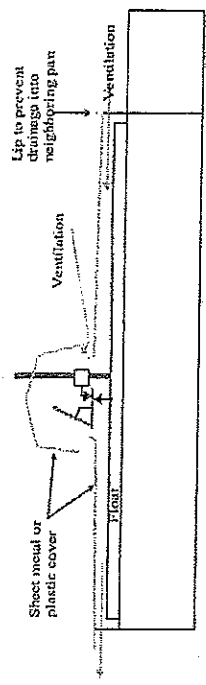
Conceptual Plan  
Dew/Insect Protection System

dew/insect guard that could be installed over the measurement pan to protect the float plate from insects and dew accumulation during the test. A pocket or port would need to be located over the mirror area so readings could be taken. Attached in Appendix A as Plate 8A is a conceptual rendering of the dew/insect guard provided by SWET.

We plan to discuss the dew/insect guard with Dr. Del Bottcher and Mr. Bill Reck. We estimate that these discussions will take approximately 2 hours per person involved. We will share concepts and prototypes. We have an estimate from a specialty shop in Southfield, Michigan for the manufacture the guard.

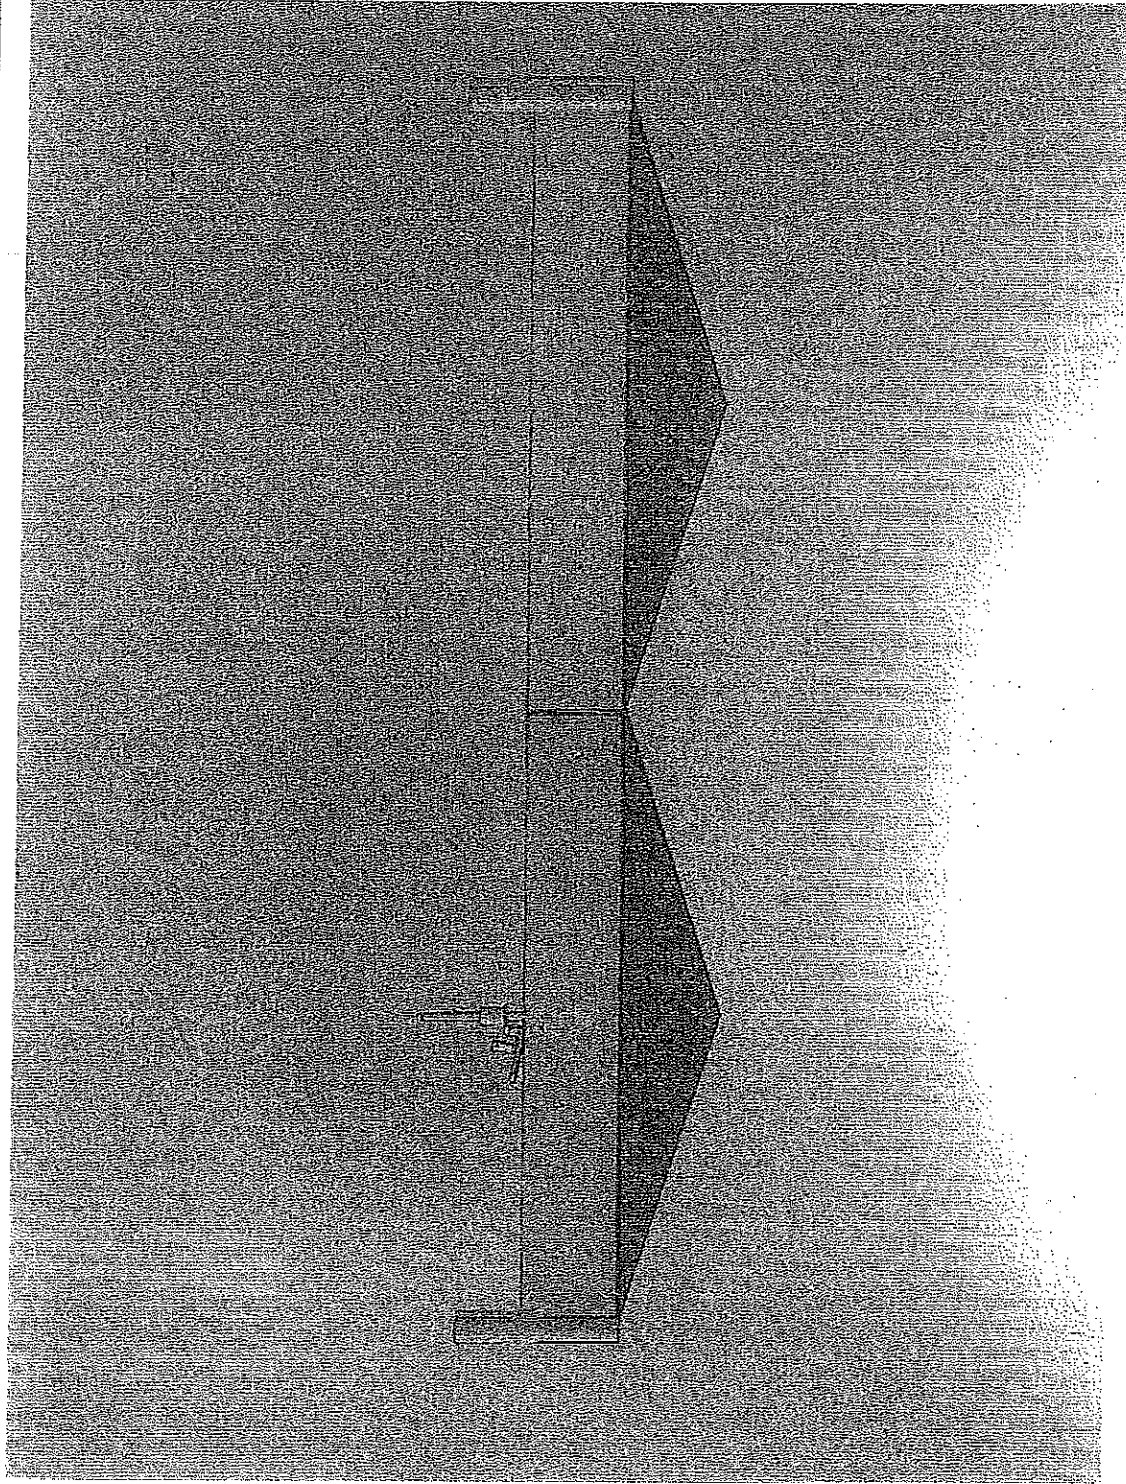
Monitoring Pan  
Profile

**January 2008** – Development of Seepage Meter shop drawings for fabrication. Dr. Del Bottcher of Soil & Water Engineering Technology (SWET) provided drawings to reference for fabrication. These drawings are included in Appendix A as Plates 1A to 8A. Thomas Fabrication, Inc. from of Mason, Michigan provided shop drawings. These drawings are included in Appendix A as Plates 1B to 4B.

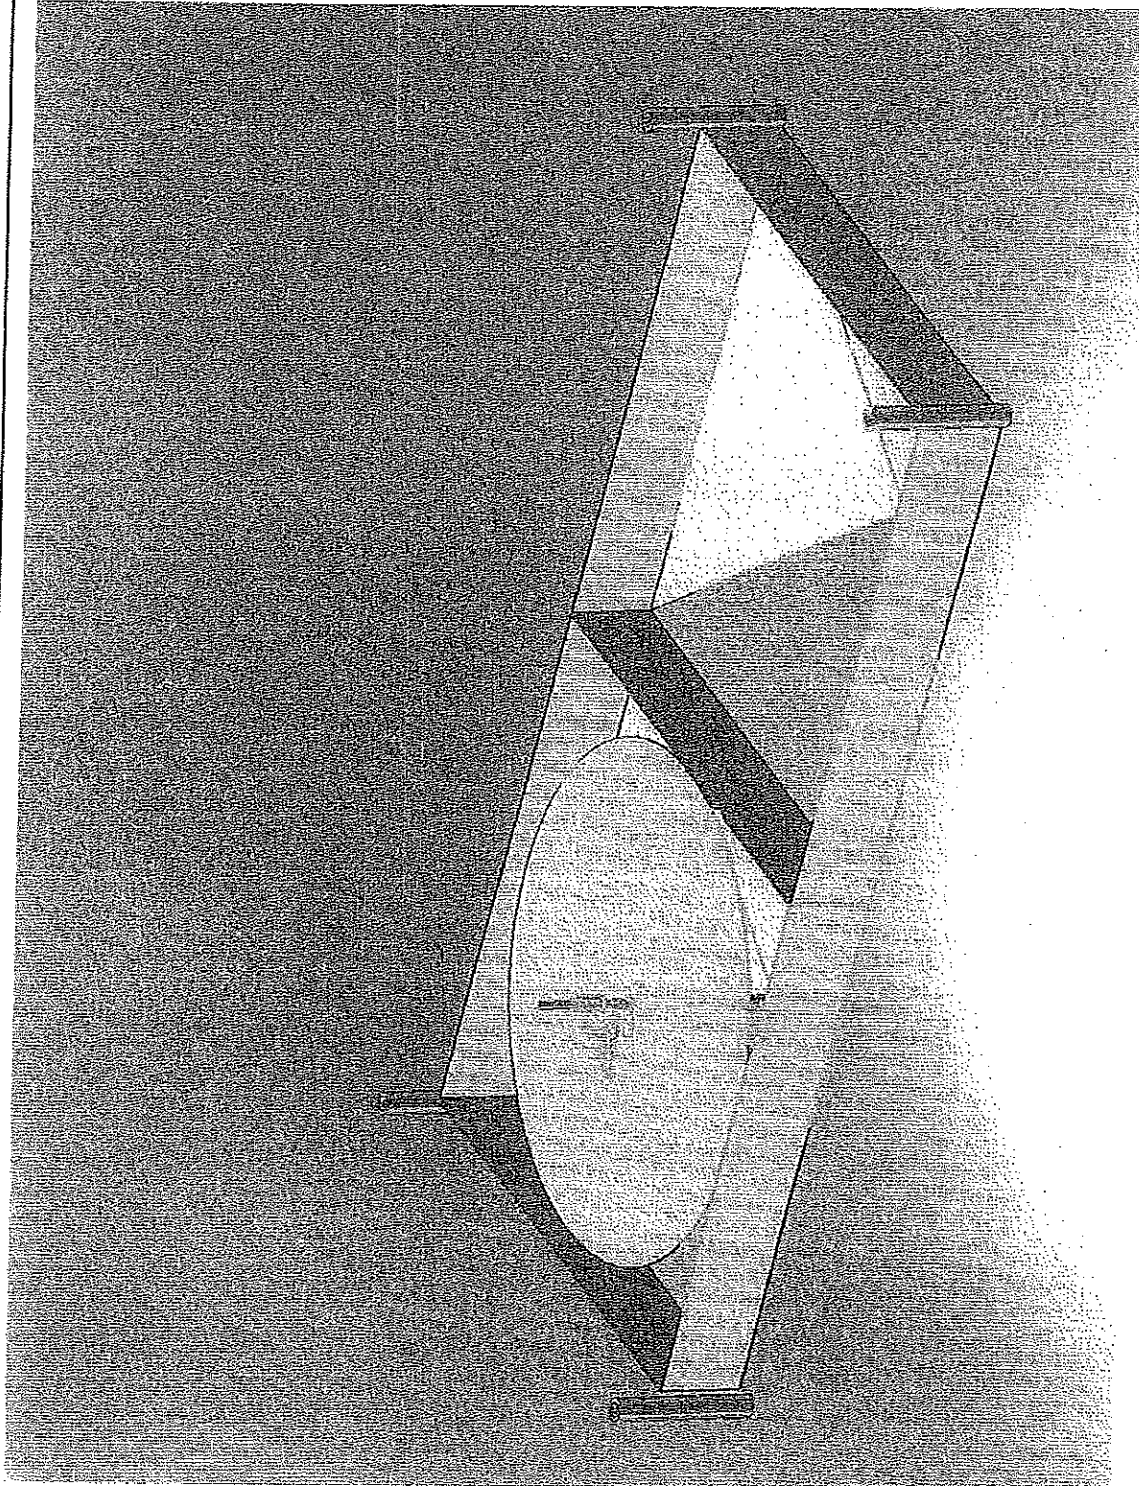
2B

Float Plate and Monitoring Pan  
Planometric View

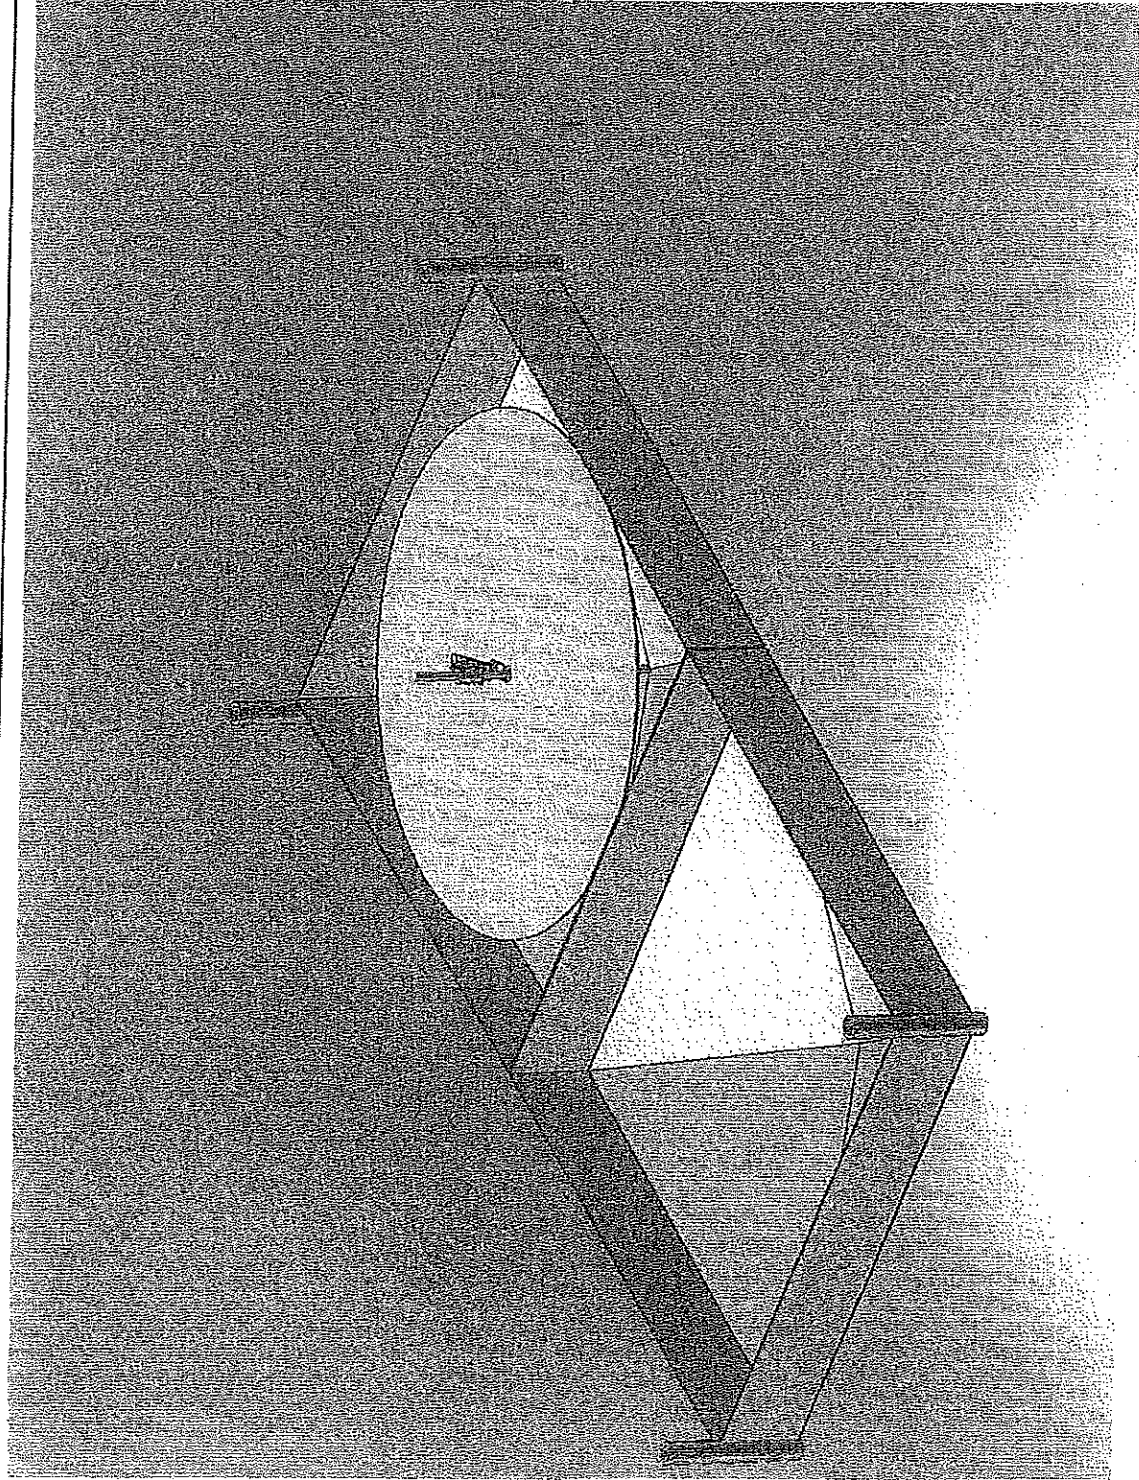
3B

Float Plate and Monitoring Pan  
Planometric View

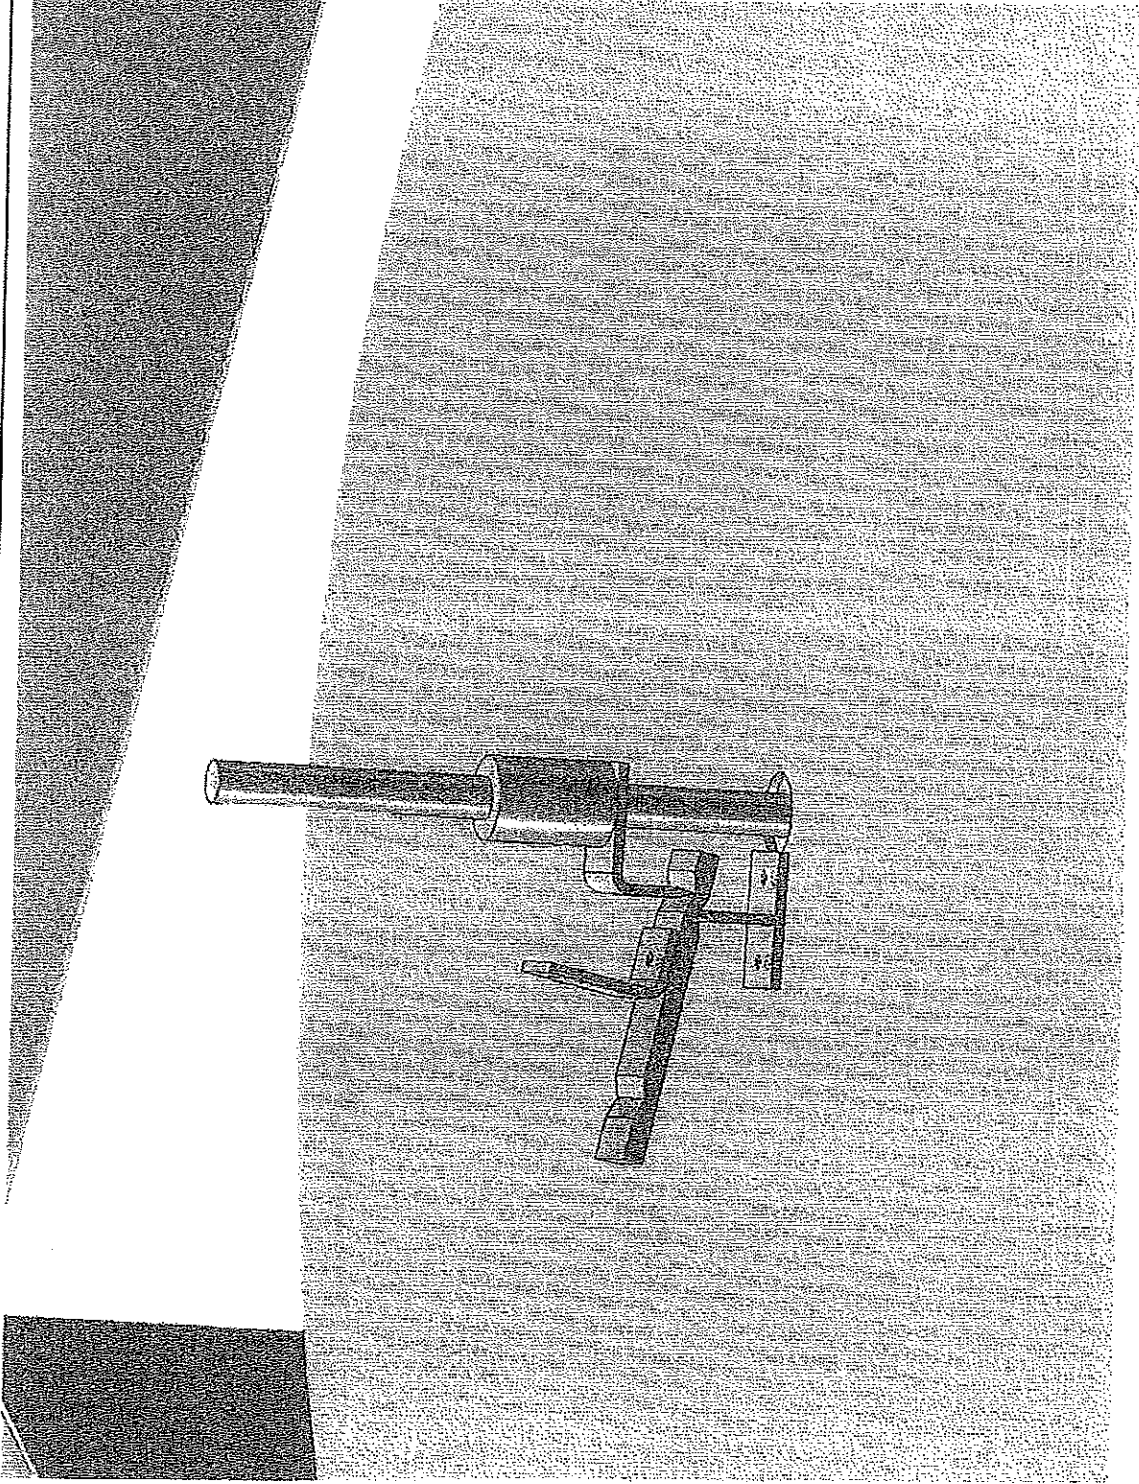
4B

Mirror and Focum Plate, Top & Bottom Blades,  
and Mounting Brackets
