Monitoring edge-of-field surface-water runoff: a three-state pilot project to promote and evaluate a simple, inexpensive, and reliable gauge

Randy S. Mentz¹, Dennis L. Busch¹, Matthew Ribikawskis², William S. VanRyswyk², and Mark D. Tomer³

¹University of Wisconsin-Platteville, ²Minnesota Department of Agriculture, ³USDA ARS Ames, Iowa

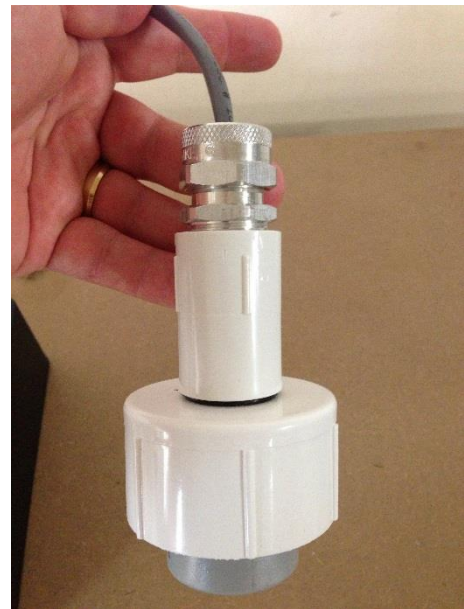
Maxbotix HRWL-WR sensors were wired into a custom weather proof enclosure and mounted above the flume and tailwater to monitor stage. The in-flume sensor is mounted upstream of the flume in the attached approach section to account for the extended drawdown curve of the water's surface during overtopping conditions. The tailwater sensor is used to detect and correct for submergence. The sensor has a resolution of 1 mm, digital output, and an accuracy of 1%.

Figure 3. Sensor with custom weather proof housing

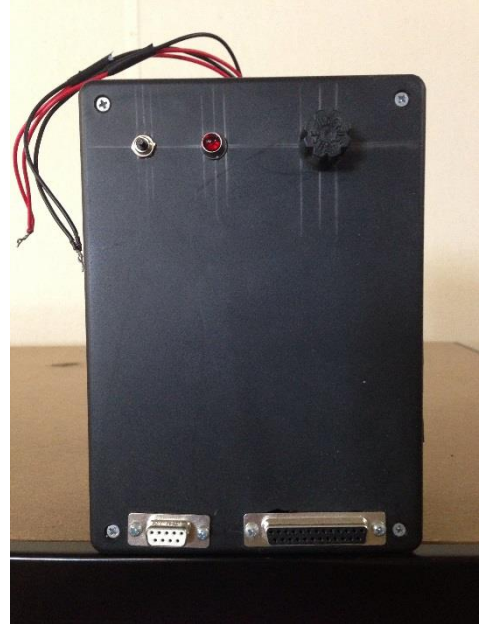
The datalogger was developed by UW-Platteville Pioneer Farm Research and the Electrical Engineering department. The first generation dataloggers lacked an on-board user interface and were wired and assembled by students. Three units were field-tested in Wisconsin for several months in 2012, but problems associated with quality control and lack of a user interface led to rapid development of the second-generation system.

Figure 4. First generation datalogger

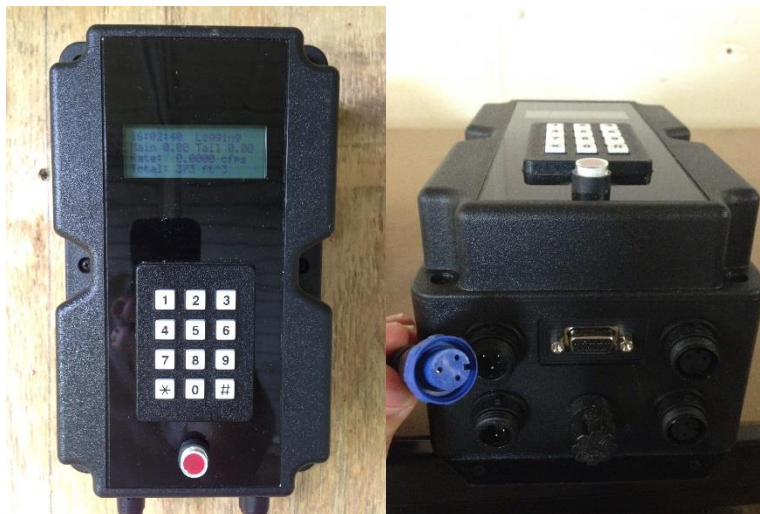
On the second-generation unit (used for the remainder of the project), a 2-row lcd screen and 3x4 keypad was added to provide a live display and on-board user interface. The second-generation datalogger also featured greatly improved wiring, plugs, and receptacles for simplified installation and component replacement. Contracted engineering firms developed the enclosure and assembled the dataloggers. These units were pre-programmed for edge-of-field monitoring and provided users with limited selectable variables such as flume type and size,

Figure 5. Second generation datalogger with lcd screen, keypad, and threaded cable connectors

greatly simplifying installation and setup. The interface featured an always-on display of live stage and total accumulated flow and also included menus to calibrate sensors and sample pump, download data, and adjust the date and time.

After the initial testing period, second generation dataloggers were rapidly developed, assembled, tested, and deployed widely for the remainder of the project. The live display and user-interface greatly reduced routine station visit times and improved technician's ability to detect malfunctions. The user interface also improved the setup and installation process since no external device (laptop) was needed to access setup menus.

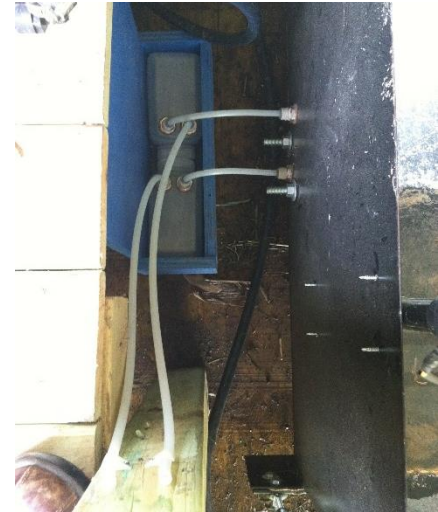
To provide a reliable backup sampler in case of power loss, passive single-stage siphon samplers were installed to sample at depths of 0.1' and 0.2'. These samplers are comprised of a bottle with connected intake and vent tubes.

The intake tube is placed in the flume, rises up to the desired sample depth, and then drops back down to the bottle, which is placed beside and below the flume. The vent tube connects to the bottle and is rises straight up to an elevation higher than the expected maximum stage. When stage in the flume

reaches the sample depth, a siphon is initiated, once the bottle fills up, no water flows in or out.

Figure 7. Single stage siphon samplers photographed from above

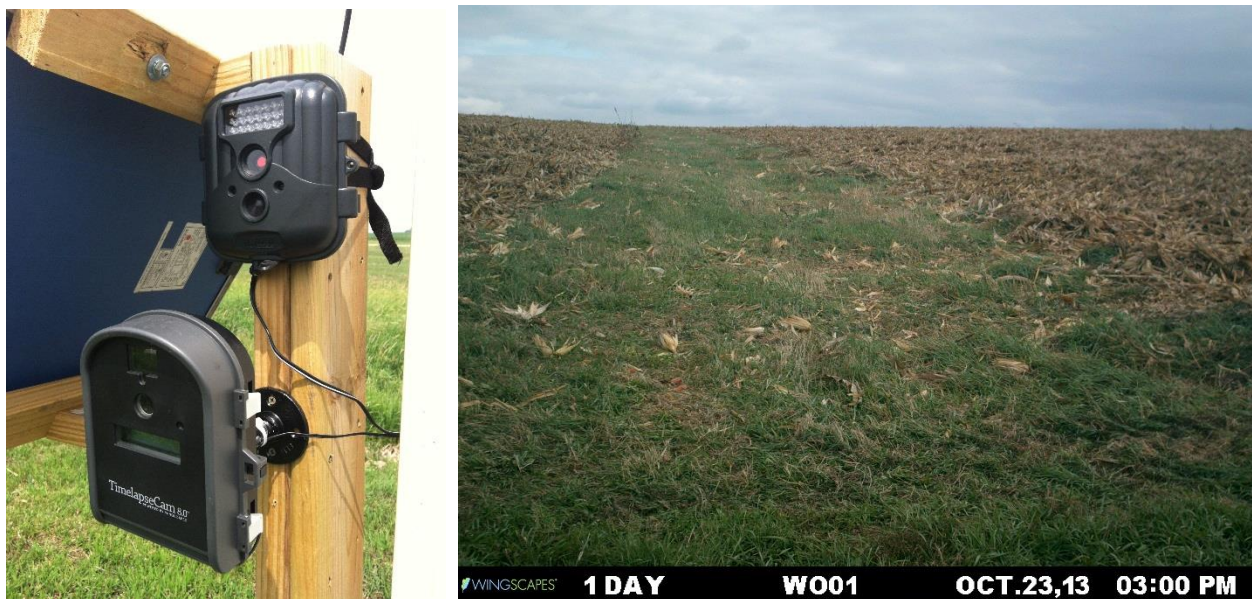
Figure 8. Timelapse and motion triggered trail camera (left). Sample timelapse image (right).

lapse camera was aimed upslope at the contributing farm field and provided a continuous record of field conditions by taking one photo per day. The motion-triggered trail camera was also pointed upslope, had a 60-foot range, and was reliably triggered by passing tractors and implements to record the type and timing of agronomic practices. The flume stage camera was pointed at the flume and staff gauge and was triggered every 5 minutes to capture a continuous record of known stage values and accompanying conditions.

Data provided from photographs provided both critical validation of data and as well as difficult challenges. Daily timelapse imagery provided by the Wingscapes TimelapseCam was the easiest to manage as the cameras reliably triggered each day and did not have power problems when connected to 12-volt power. However, the daily images provided only field conditions, rarely capturing agronomic activities. The motion-triggered cameras were triggered by passing field equipment, providing a more complete record of agronomic practices. However, these cameras failed more frequently, especially after being in the field for a year. They also were prone to recording hundreds or even thousands of images caused by grass blowing in the wind, birds, and other natural movements. Images of flumes with staff gauges taken every five minutes provided very valuable stage validation data used to document the accuracy of the stage sensor. Images of the flume during flow identified turbulence, ice, submergence, and other factors that

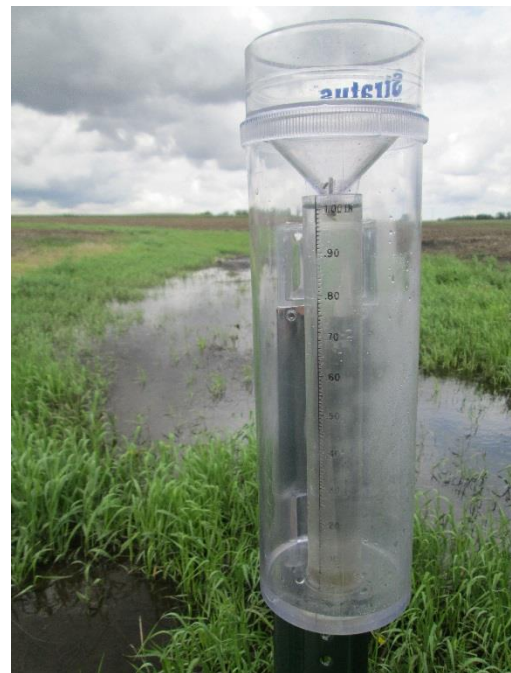
A Stratus RG202 manual precipitation gauge was used to record on-site precipitation. This unit has a maximum capacity of 11 inches and is accurate to 1/100th of an inch. This gauge was serviced upon each site visit, with precipitation data recorded in the field log.

Figure 9. Stratus RG202 precipitation gauge

The precipitation gauge provided a basic measurement of total rainfall, but the data generated does not quantify rainfall intensity. While the gauge is designed to measure snowfall, the plastic was prone to cracking over the winter months if pooled water froze in the cylinder. For that reason, the gauge was typically uninstalled during the winter season. For observational studies and adaptive management, this record is sufficient, however for research purposes, a tipping bucket rain gauge is recommended. In hindsight, the precipitation record could have been greatly improved if installed at a nearby cooperator's residence so that it could be checked more frequently.

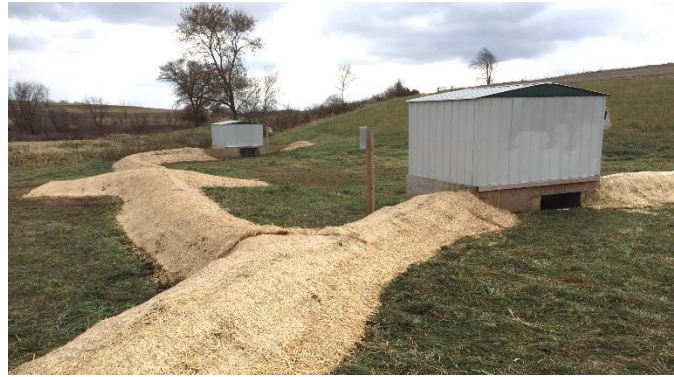
In-line stations were installed where the experimental equipment was in a series with an existing conventional edge-of-field monitoring site. The in-line sites provided the opportunity to compare prototype and conventional station operation and results, while also providing a useful complement of equipment for field days and training.

Figure 10. Wisconsin in-line installation with soil berms to prevent run-on between stations. The prototype (right) was positioned upstream of the conventional station (left)

The in-line setup in Wisconsin was installed in a waterway with minimal relief, as a result, the stations needed to be about 200 feet apart such that ponding at the downstream flume would not back up into the upstream flume.

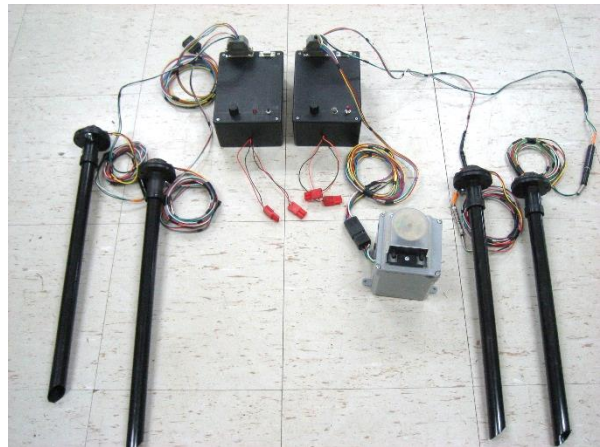
Production of a working prototype was underway at the beginning of the project. Students in the UW-Platteville Electrical Engineering department were assembling dataloggers and wiring sensors and pumps to begin field testing. After the first units were installed and tested for several months, the failure rate was too high to further deploy and use the initial system for the field test. The backup power system was designed to switch to a smaller backup battery when voltage was detected to be too low. While this makes sense, the implementation of the switch did not factor in momentary voltage drops caused by the sample pump starting. Dataloggers would trigger the first sample of a runoff event causing a momentary voltage drop and switch over to the smaller battery for the remainder of the runoff event as the primary power can only be restored during a field visit. This resulted in power failures and data loss since the smaller batteries didn't have the capacity to serve as primary power sources during runoff events. Without a live display, laptops were carried into the field and connected to the prototype dataloggers to check stage, adjust settings, and collect data. With primary and backup dataloggers at each station, field visit times became too long. Sensors used on the first generation system proved to be too unreliable for field use. Finally, the complexity of the assembly introduced too many errors into the datalogger and wiring.

Figure 12. First generation electronics kit including primary and backup dataloggers and sensors, sample pump, and wiring harnesses

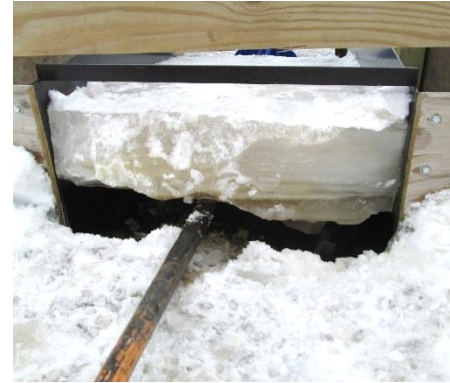
The MHXL flume reduced both installation and labor costs. The low-profile of the MHXL flume resulted in soil berms that were smaller in both height and length than what would have been required for equivalent H-flume installations. The integrated heater proved to be a major time-saver for removing ice of any thickness. Ten to twenty minutes after starting the heater, the bond between the flume and the ice would be melted free and the ice could easily be removed.

Figure 14. Thick ice easily removed after running the flume heater for ten minutes

Conventional flumes required hours of manual labor to break and remove ice in small pieces. The propane RV shower heater was prone to damage caused by mice and openings were covered with hardware cloth to keep mice out.

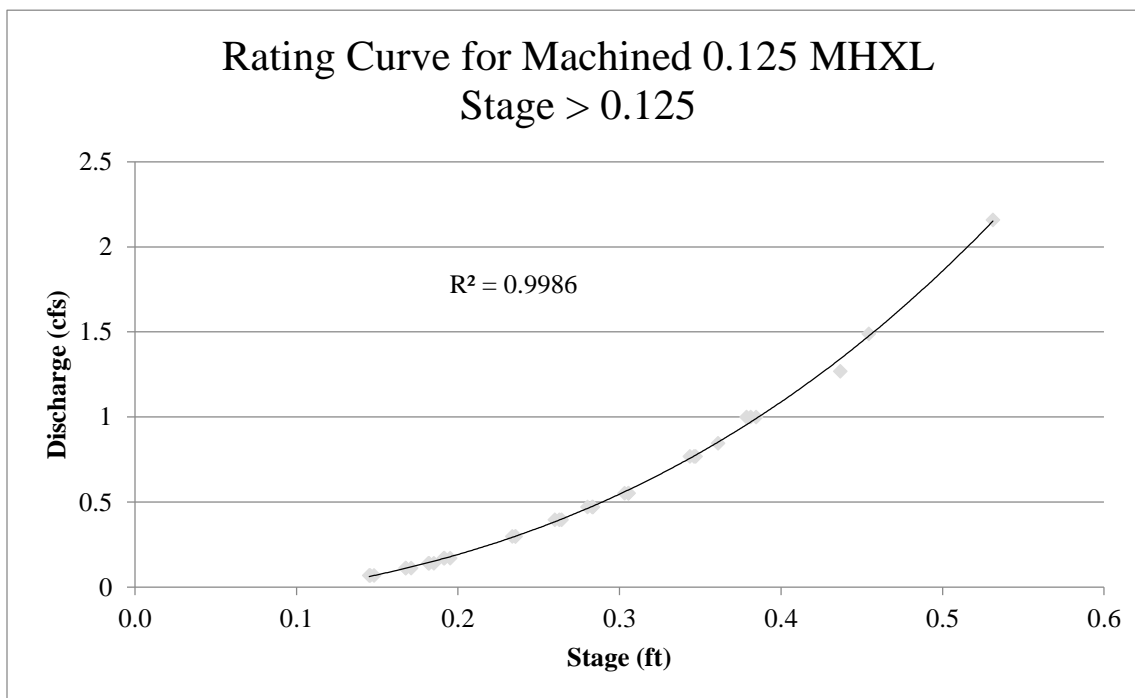
strong relationship between stage and discharge and are included below ($\leq 0.125'$ stages $R^2 = 0.9958$, $> 0.125'$ stages $R^2 = 0.9986$).

Figure 16. Rating curve for machined 0.125 MHXL flume for stages greater than 0.125 feet

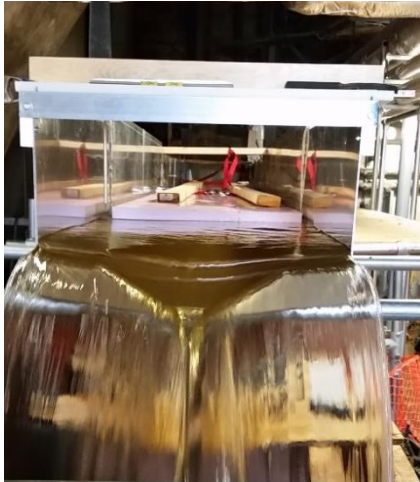
In an effort to reduce cost, alternative flumes were constructed using state-of-the-art CNC metal cutting and bending techniques. This manufacturing technique reduce cost of flumes by approximately 60%. Several of these flumes were evaluated at the SAFL to determine accuracy and precision of discharge estimates.

Figure 17. MHXL flume flowing at St. Anthony Falls

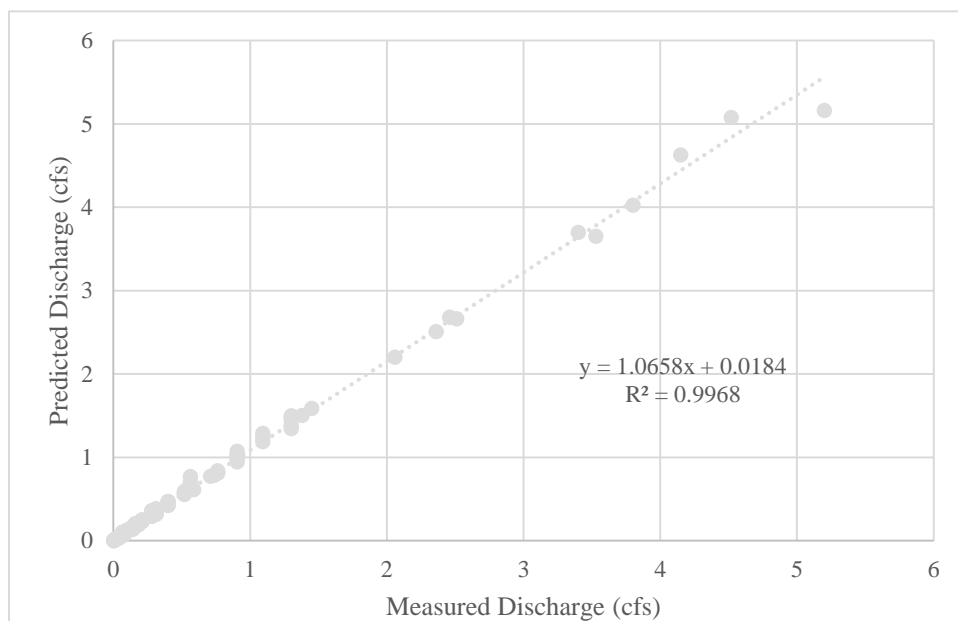
In order to determine accuracy and precision of flume discharge estimates, 138 pairs of stage and discharge measurements were obtained from 12 prototype flumes. The stage values were used to determine estimates of discharge using a scaled version of the 0.125' rating curve. This data was compared to measured discharge obtained using time capture techniques for low discharges and flume (1.0' and 2.5' H-flumes) measurements for higher flows. Figure 18

illustrates that the low-cost MHXL flumes produced precise estimates of discharge ($R^2 = 0.9968$)

Figure 18. Linear regression of measured discharge against predicted discharge (based on scaled 0.125' MHXL rating curve)

but the results were less accurate than the more expensive machined flumes and generally underestimated discharge (slope of the line = 1.0658).

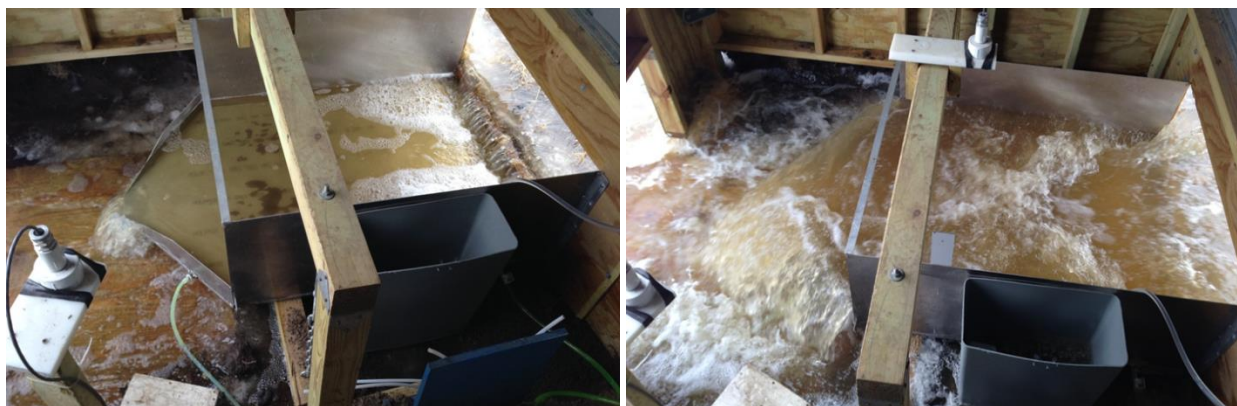
While results are encouraging, lab and field test results indicate that at high discharge rates flow within the flume becomes turbulent and difficult to gauge- this condition is exacerbated with below-grade installations. Such conditions may be resulting in underestimation of discharge rates.

Figure 19. Low quiescent flow (left) and high turbulent flow (right)

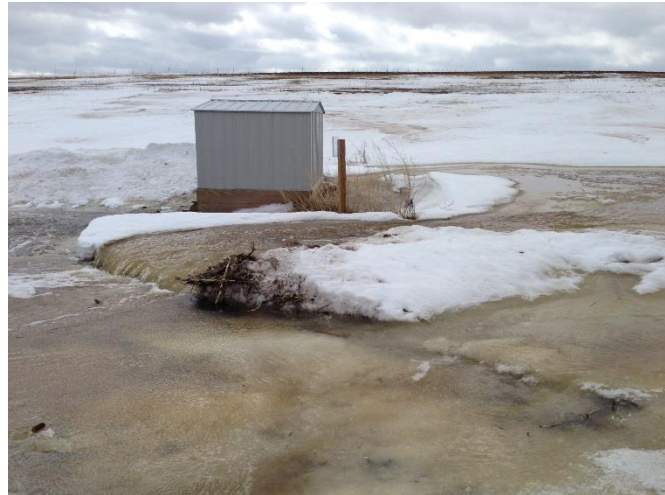
The waterway in between was bermed to prevent run-on that would increase flow at the downstream flume. Unfortunately, the snow distribution prior to the first and largest runoff event directed runoff water over a berm near the upstream station allowing runoff water to bypass the

Figure 20. Wisconsin in-line station with bypass

prototype gauge and flow through the conventional gauge downstream until the issue was discovered and corrected. The narrow shoveled path through the snow upstream from the prototype station coupled with high volume resulted in high-velocity water flowing into the prototype flume. This flume was also installed below-grade, further accelerating the water and increasing turbulence. The downstream channel through the snow was much wider, allowing runoff water to slow down and spread out before reaching the at-grade conventional h-flume. All of these issues were corrected after the first runoff event, however only one other runoff event occurred.

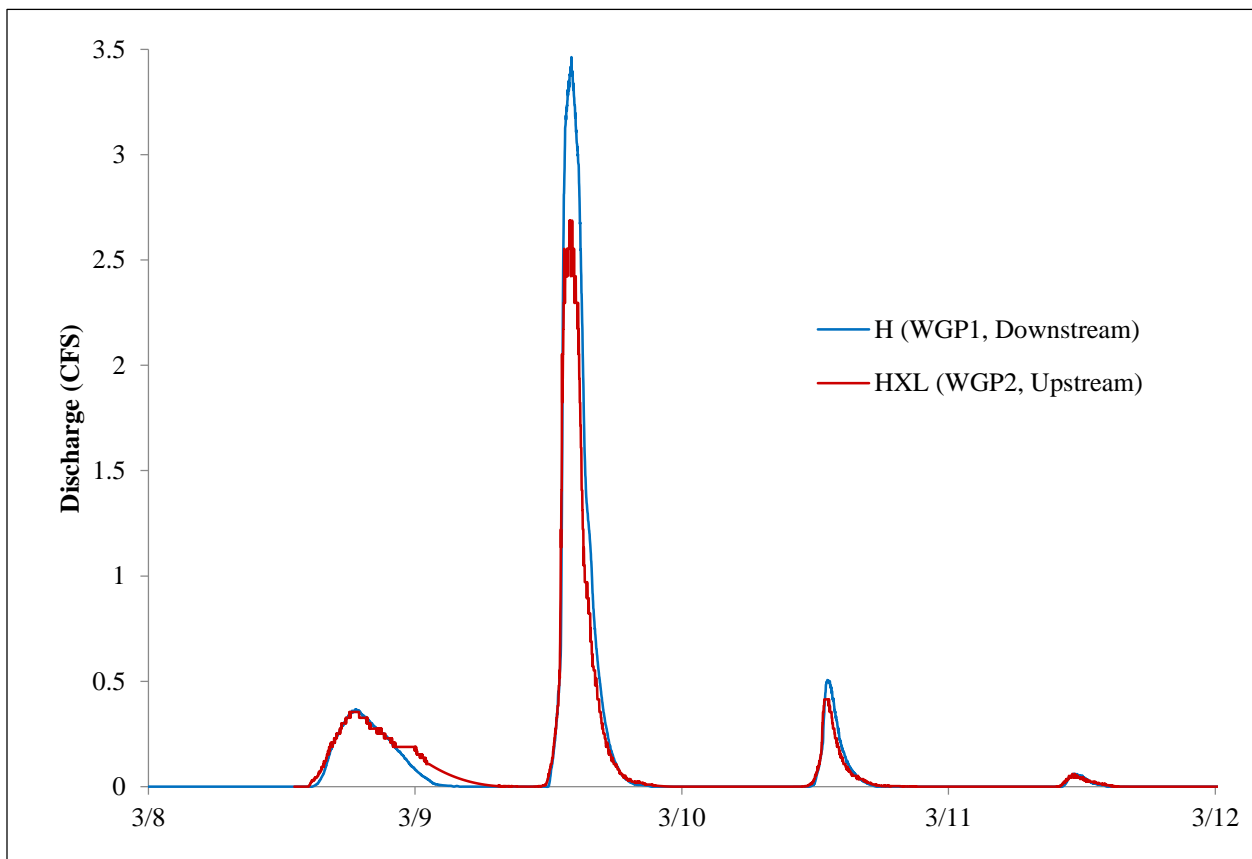
Figure 21. Discharge hydrograph of Wisconsin in-line stations during the 2015 snowmelt runoff event

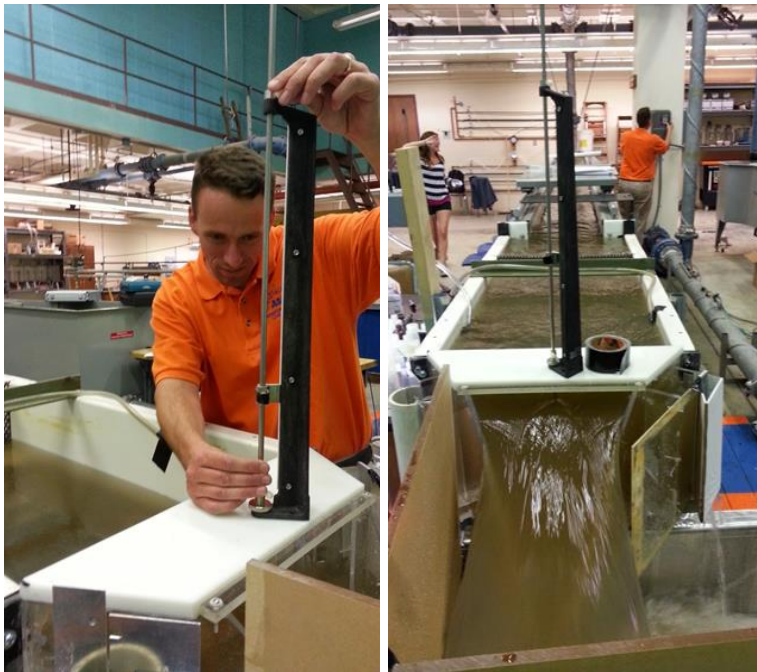
Prior to conducting the laboratory trials, soils were collected from the UW-Platteville Pioneer Farm to create a synthetic runoff. Soils were collected from the top 5 cm of the soil surface of cultivated fields. The collected soil was then dried and sieved. The sieved soil was then added to the recirculating flume in the UW-Platteville Environmental Engineering Laboratory. The recirculating flume consists of a collection tank, constant head tank, approach section, and flume (1.0 H-flume). Stage depth in the flume was determined using a 60 mm point gauge (Armfield). Agitation/circulating pumps were added to the collection tank to maintain soil

Figure 24. Point gauge measurement of water surface (left), h flume and approach during high flow trial (right)

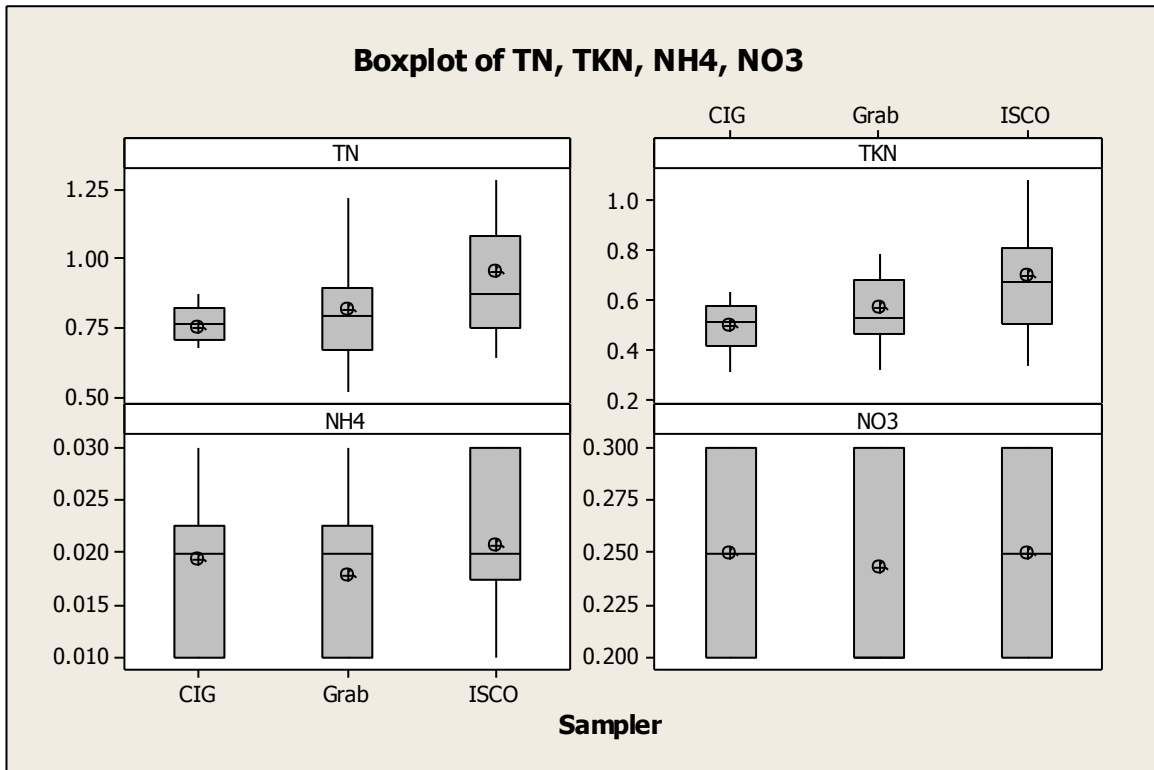
collection prior to transport to the UW-Stevens Point Water and Environmental Analysis Laboratory for analysis. The graphs below illustrate interquartile ranges and mean values for all constituents by sampler type. The charts indicate that the CIG sampler produced similar results compared to the grab samples, and concentrations from samples collected with the ISCO sampler tended to be slightly higher in concentration than the CIG and grab samples. Results of Analysis of Variance statistical test indicate that the type of sampler had a significant ($p=0.05$) effect on sample TKN and TN concentrations.

Figure 25. Boxplot of TN, TKN, NH4, and NO3 concentrations

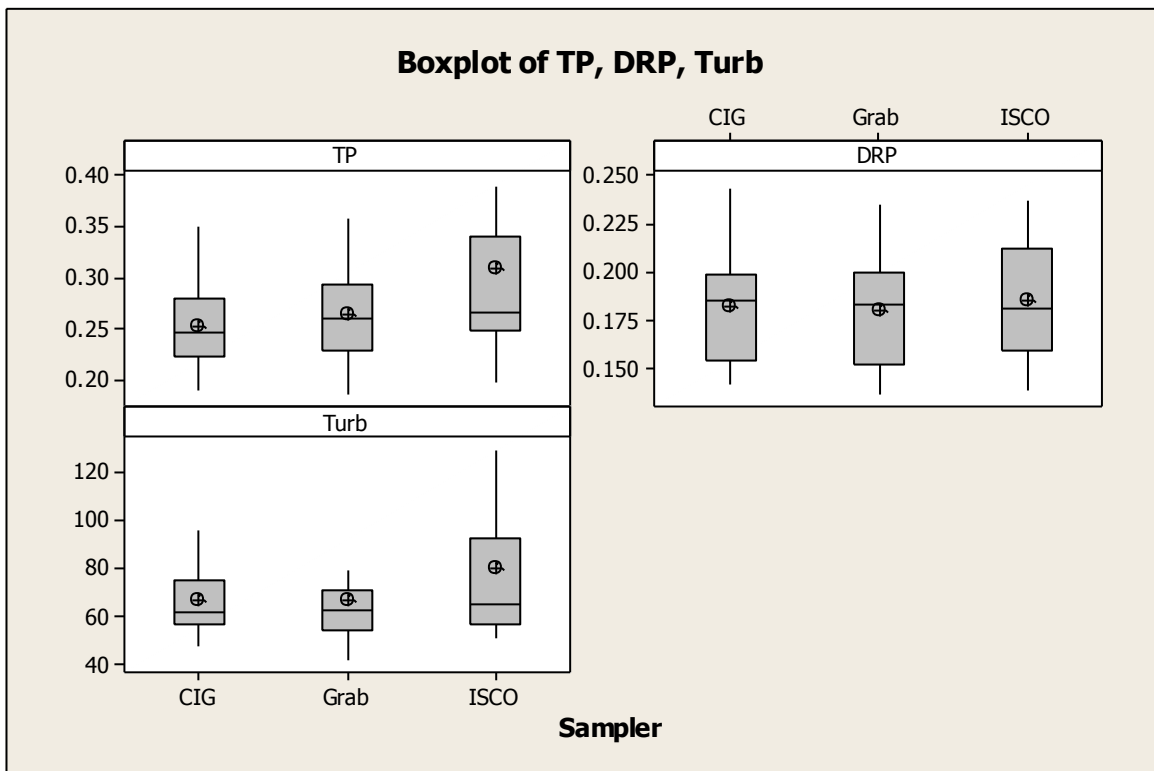
Figure 26. Boxplot of TP, DRP, and turbidity concentrations

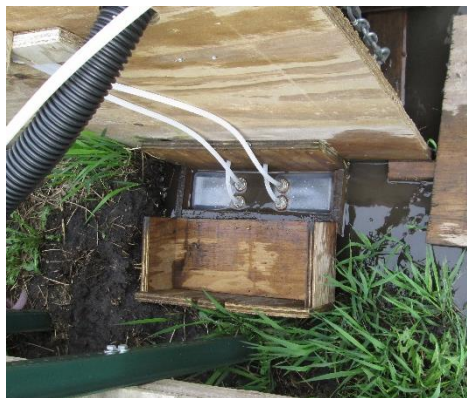
Passive samplers worked as expected during the warm seasons and captured samples from all but the smallest events. The samples are not representative of the entire event, but they

Figure 27. Passive samplers submerged after a runoff event

provide some water quality information in when electronics malfunction. While they did work, they were very difficult to access and replace, adding significant time to field visits. If the samplers did not seal properly, water would continually flow through them during runoff events, creating a sediment trap and biasing the sample. The biggest problem with passive samplers was submergence.

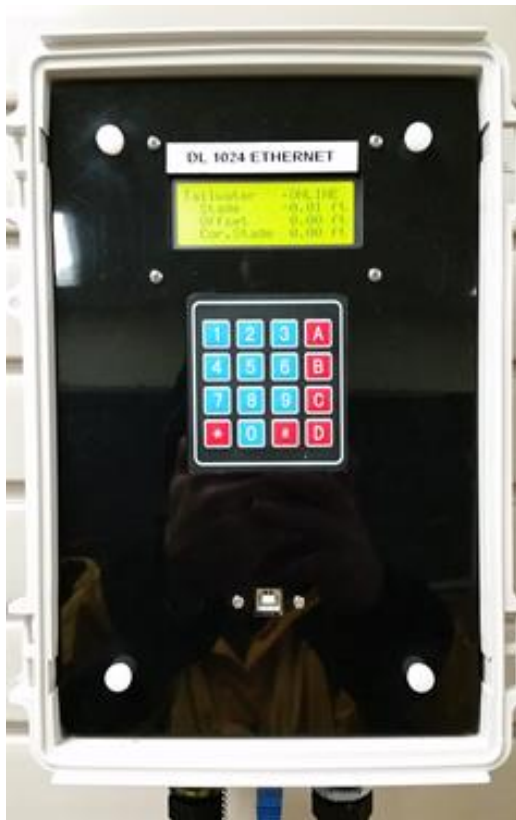
Figure 28. Current generation datalogger with improved feature set

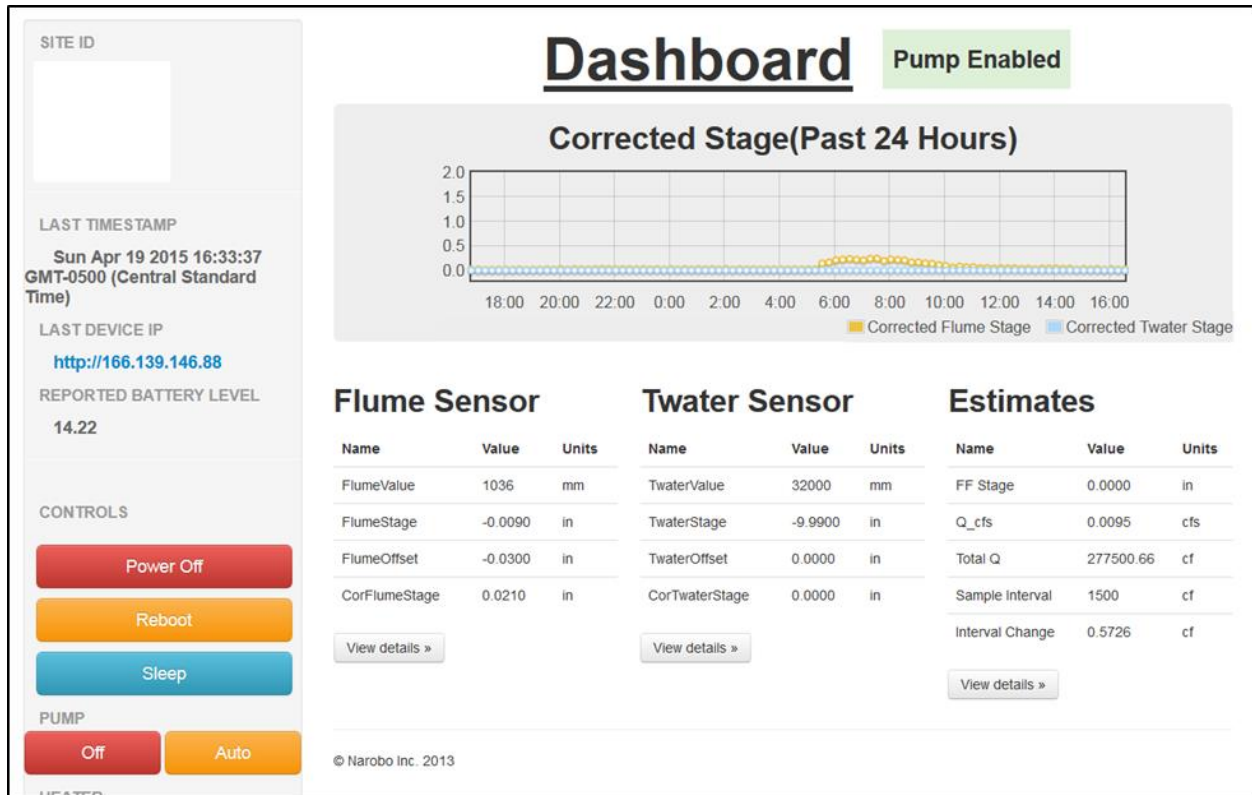
Figure 29. Online dashboard with recent data and remote controls
